*A Pictorial Essay Of The Poor Learning Environment In Selected Schools In
Ikara And Sanga Local Government Areas Of Kaduna State*

Produced by
Community Life Project (CLP) - Reclaim Nigeria

COMMUNITY LIFE PROJECT (CLP)
SEPTEMBER 07, 2020

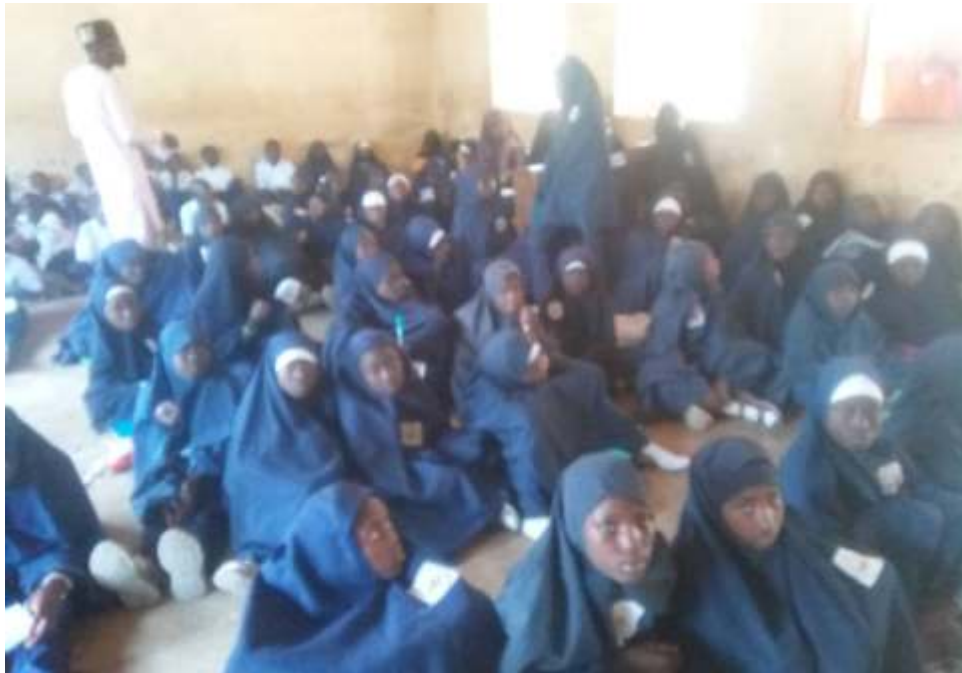
Government Junior Secondary School, Ikara, Ikara LGA. Students sit on the floor without reading tables and chairs.

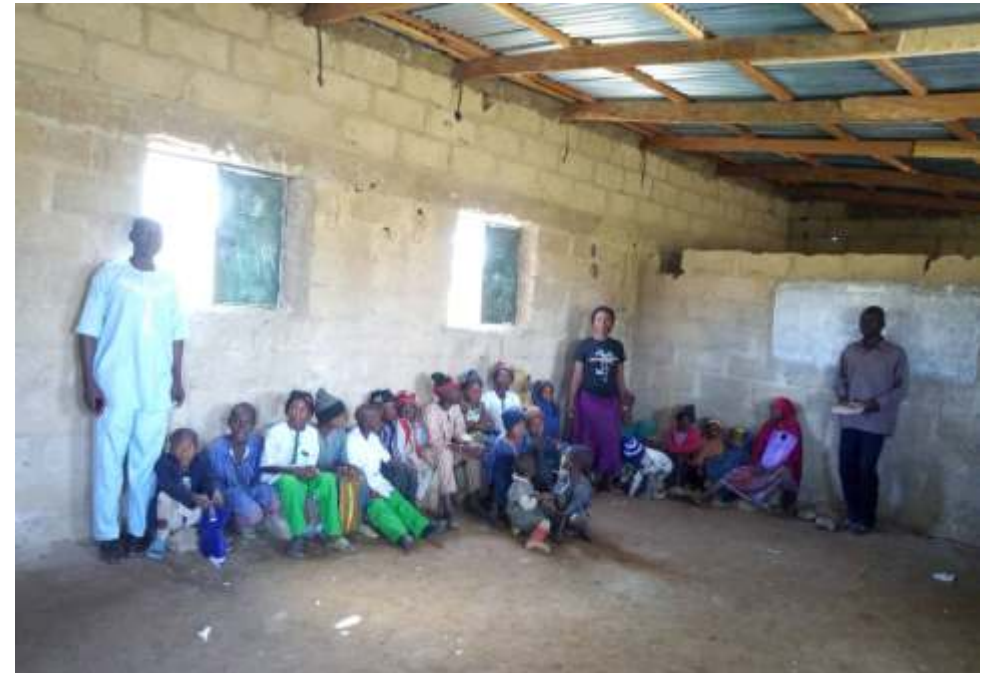
LGEA Primary School, Anguwar Gani, Ikara LGA. Pupils sit on the floor without reading tables and chairs.

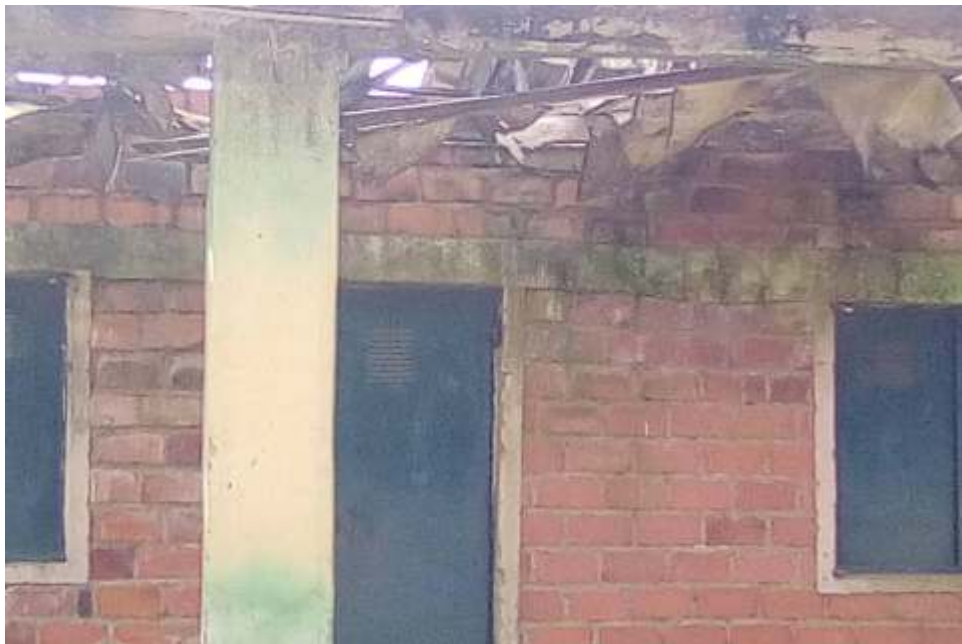
LGEA Primary School, Anguwar Nuhu, Ikara LGA. The classroom ceiling board is dilapidated.

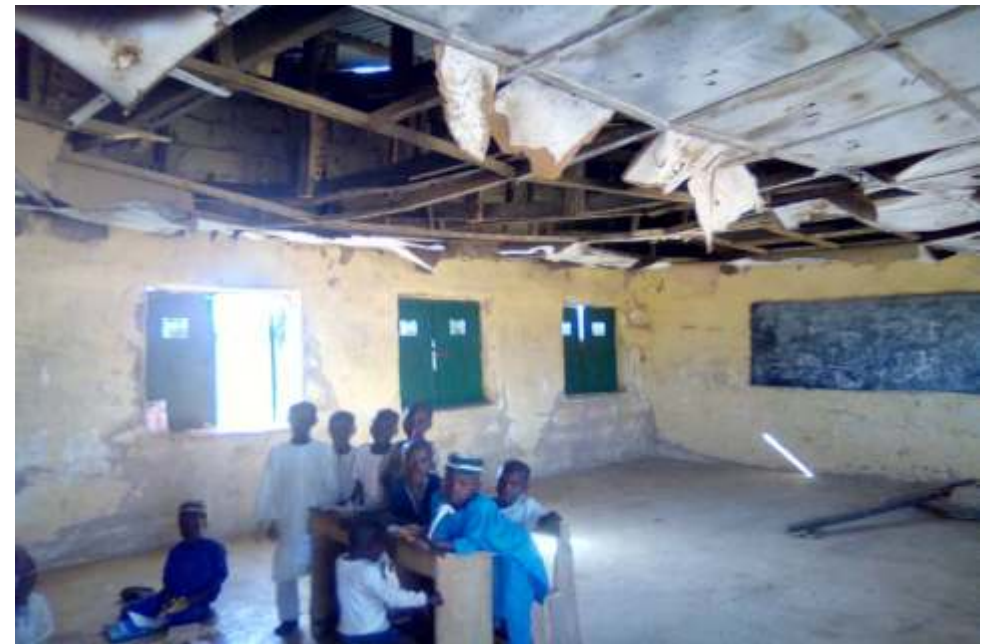
LGEA Primary School, Anguwar Mudi, Ikara LGA. The classroom's ceiling board is dilapidated.

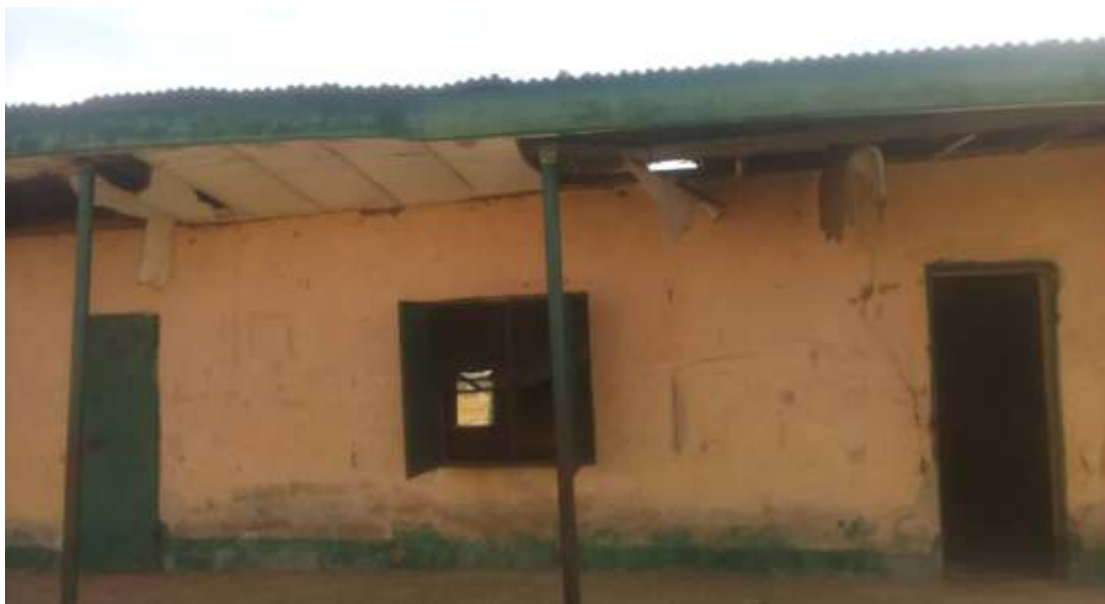
LGEA Primary School, Anguwar Halliru, Ikara LGA.
The veranda ceiling board is dilapidated.

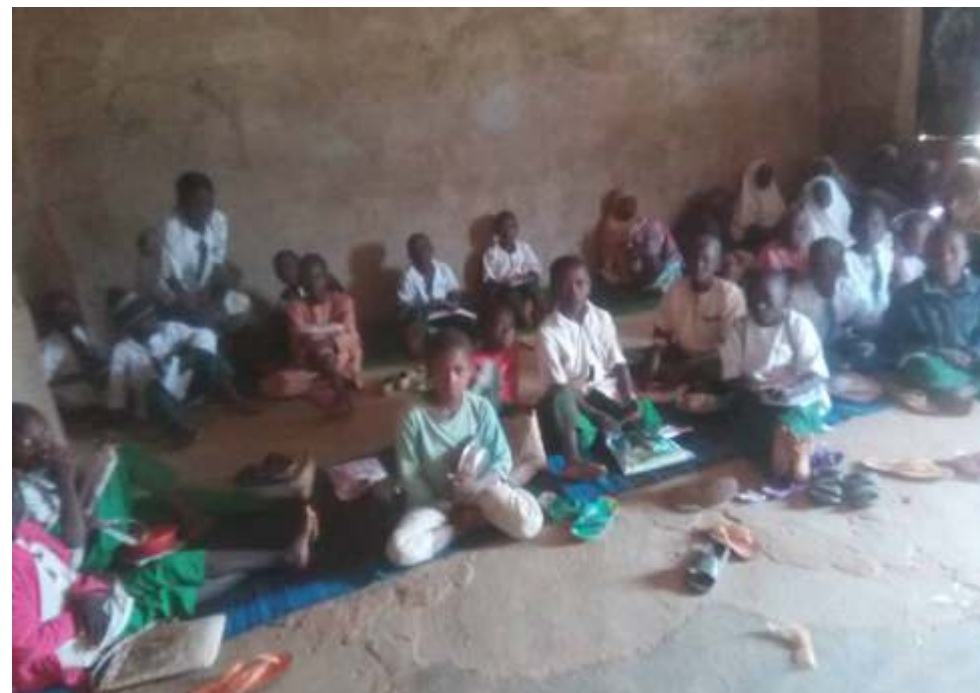
LGEA Primary School, Kankanki, Ikara LGA.
Pupils sitting on the floor without reading
tables and chairs.

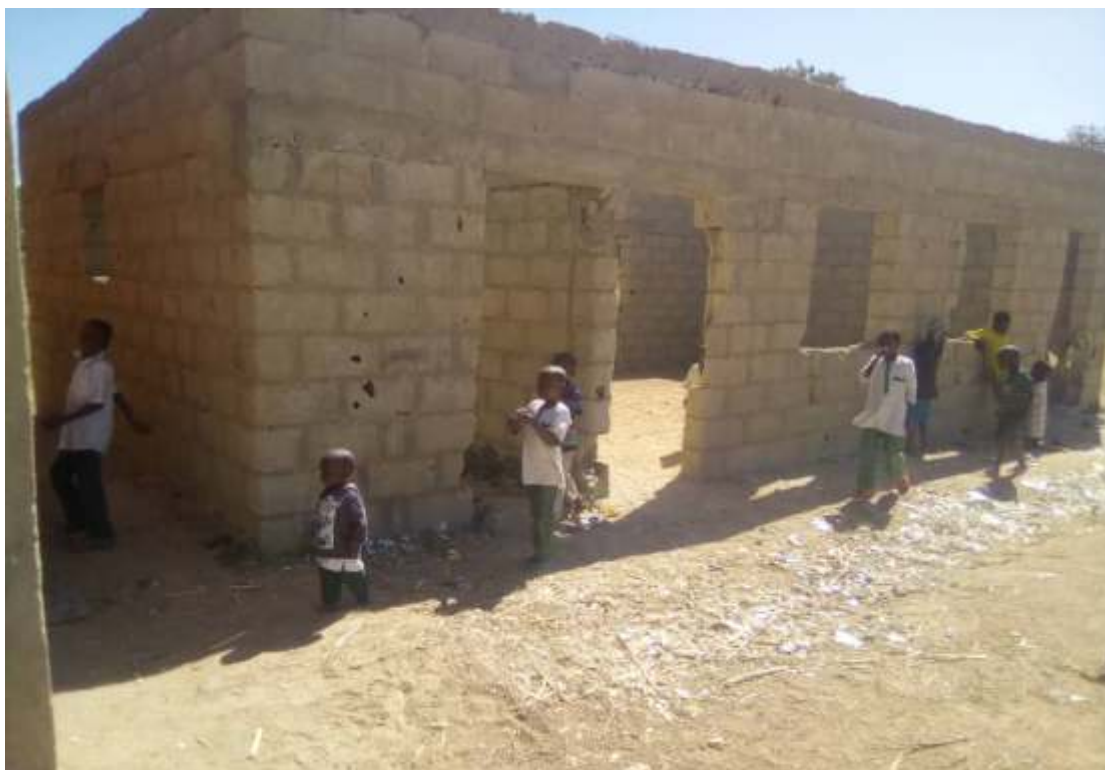
LGEA Primary School, Mafera, Tudun Labi Kwari, Ikara LGA.
Un-completed classrooms building.

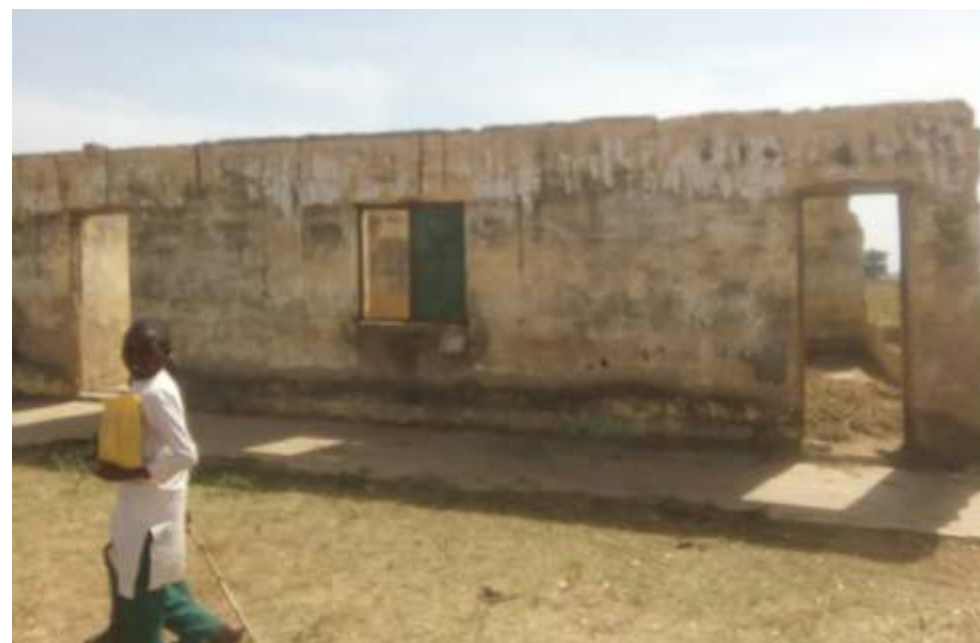
LGEA Primary School, Makera, Ikara LGA. The roof
of the block of classrooms blown off by wind.

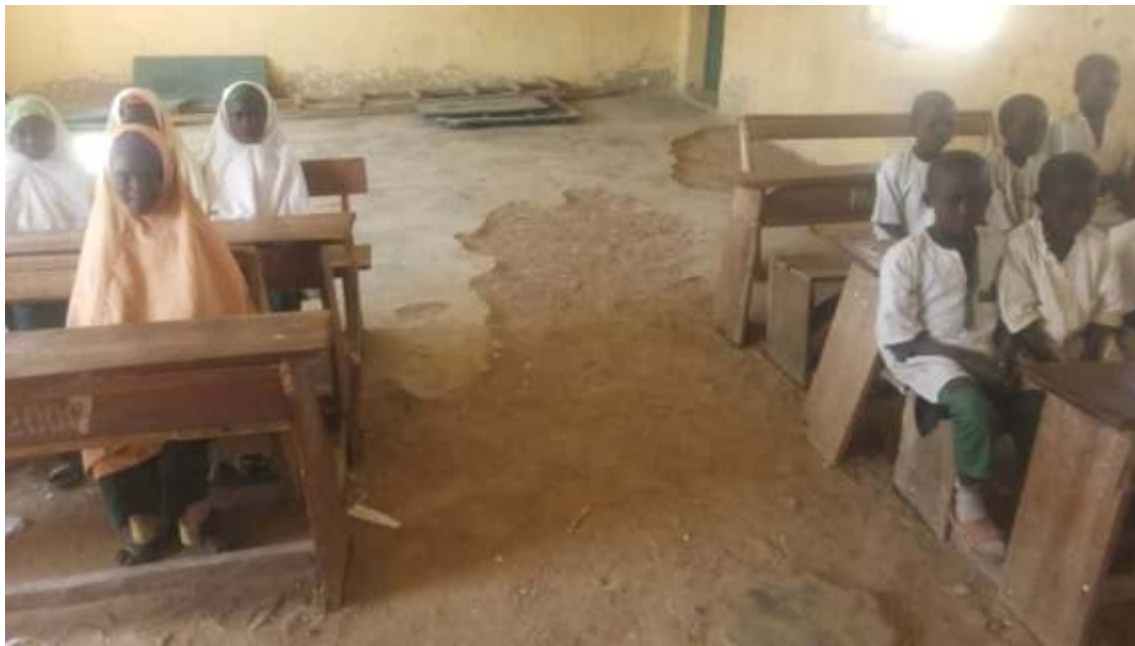
Ikara LGA - LGEA Primary School, KwaKwa, Ikara LGA. The floor of the classroom is broken. Dangerous to the pupils' health

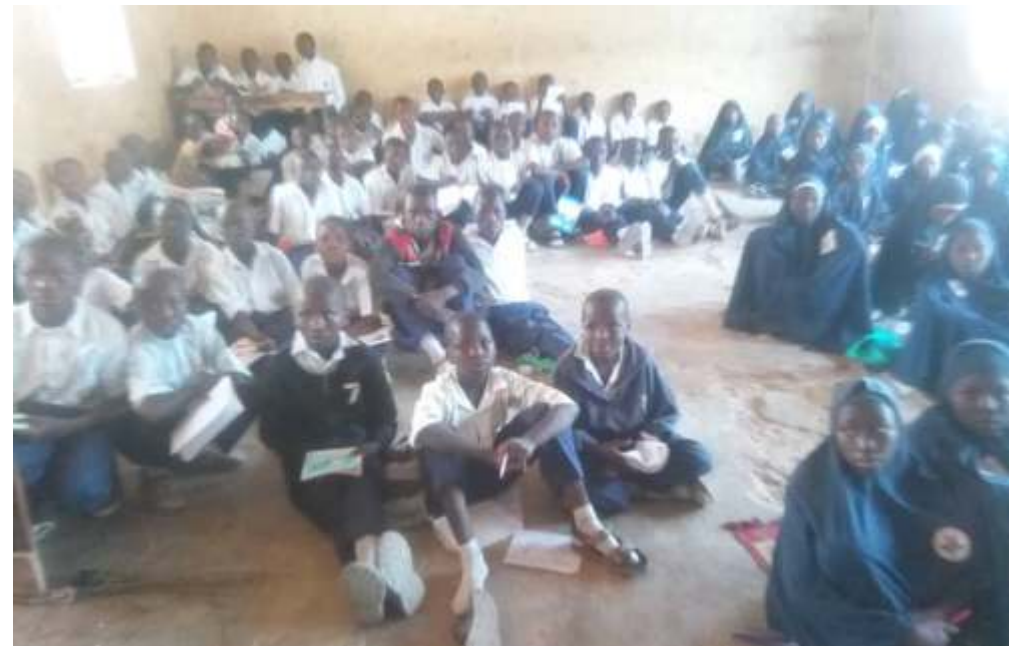
Government Junior Secondary School, Auchan, Ikara LGA. Students sit on the floor without reading tables and chairs.

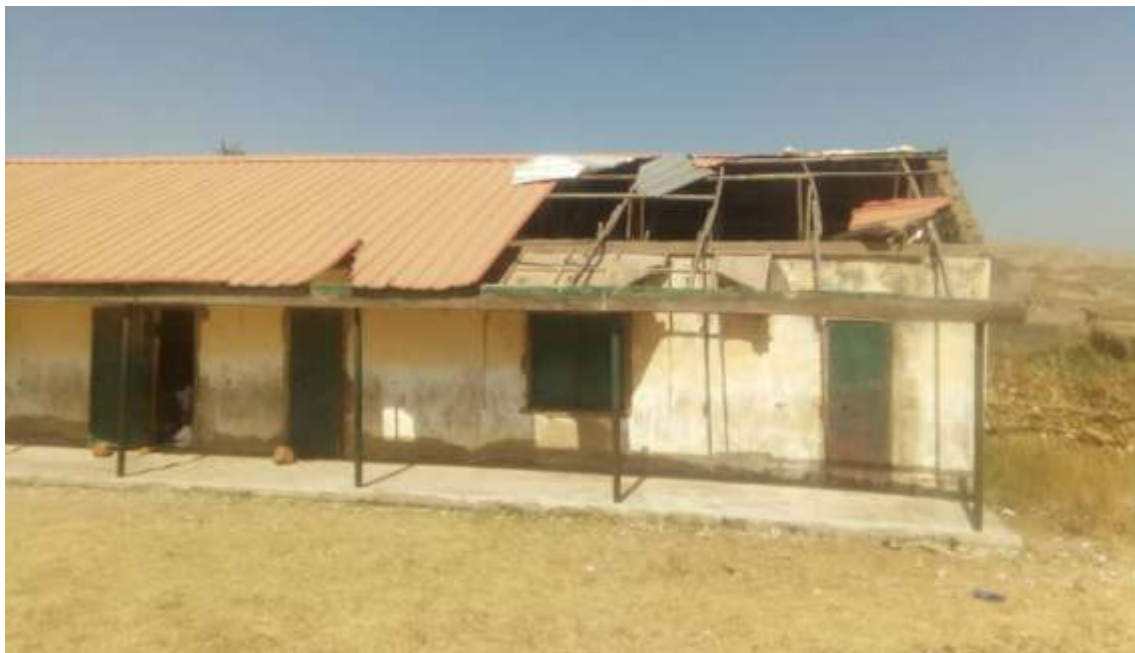
Abdullahi Adamu Model School, Ikara, Ikara LGA. The roof of a classroom blown off by the wind.

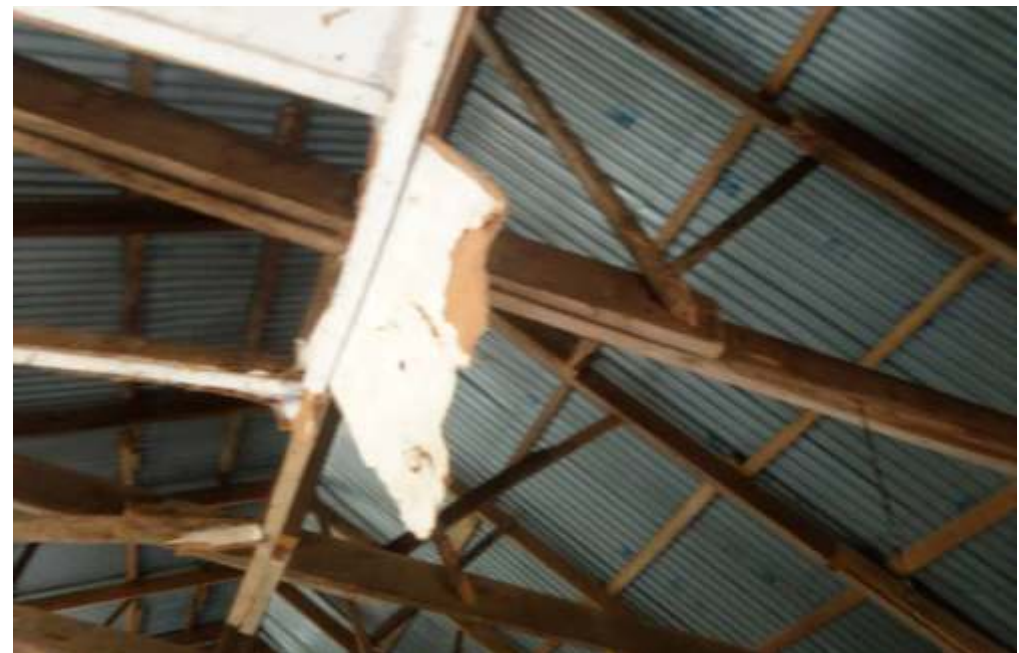
LGEA Anguwar Primary School, Anguwar Mukaddas, Ikara LGA. The classroom ceiling board is dilapidated..

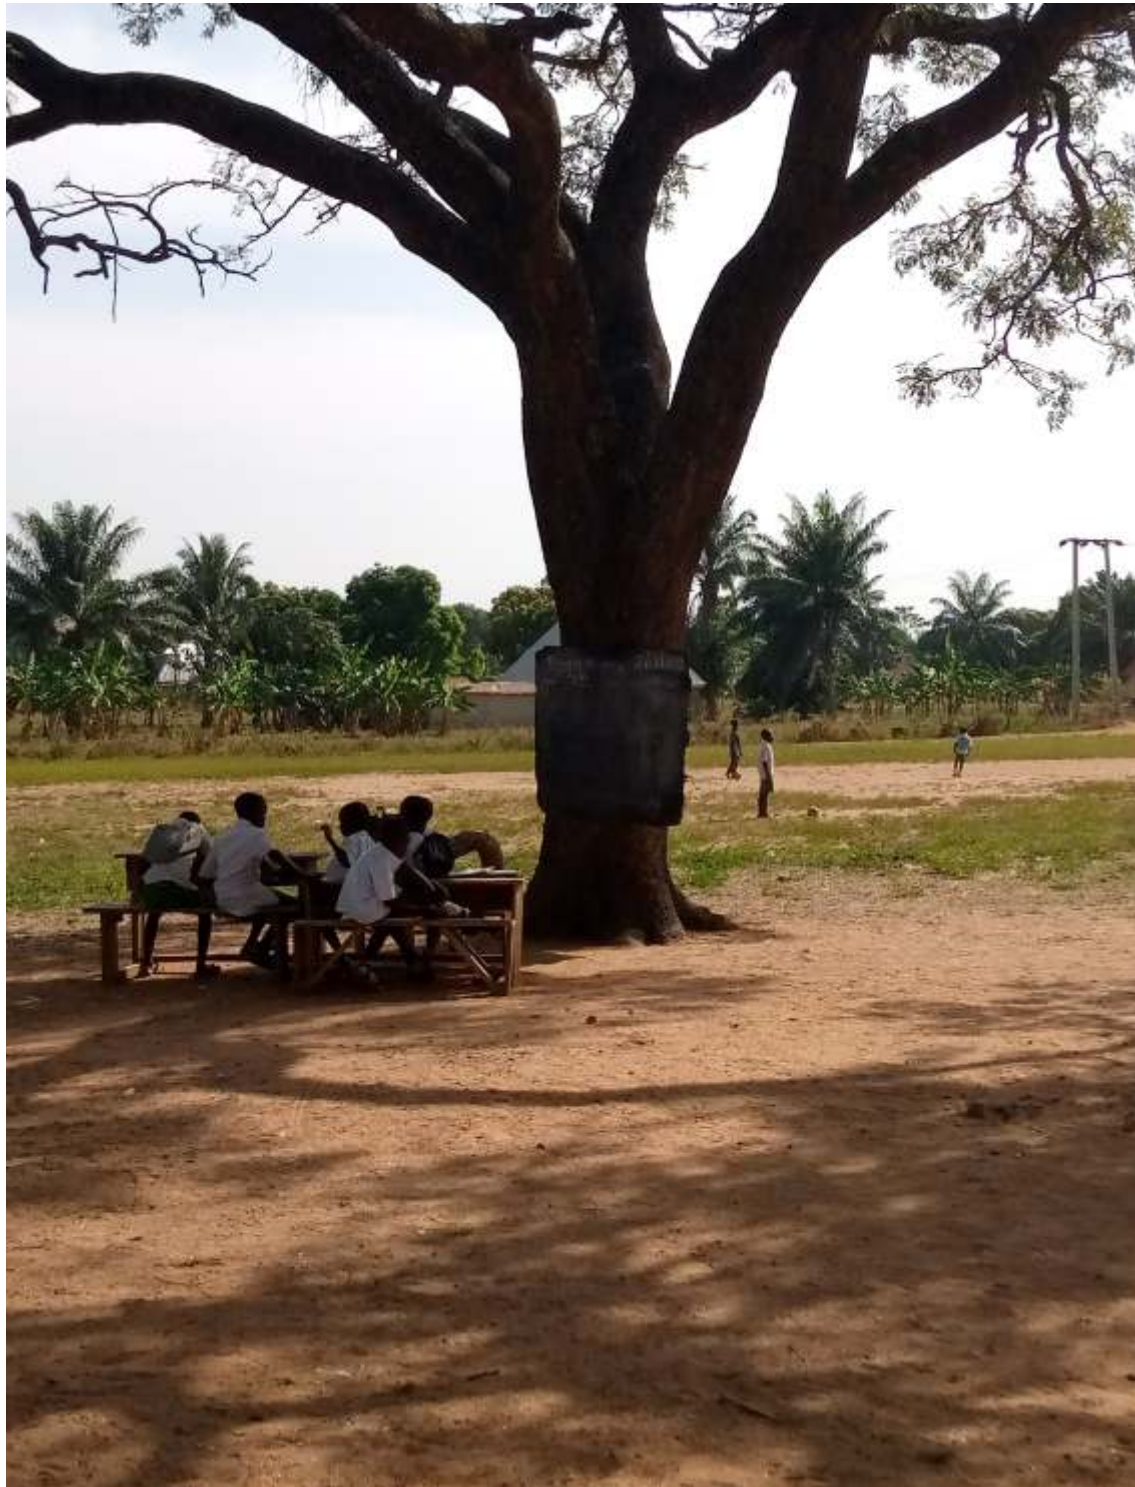
LGEA Primary School, Tsauni, Sanga LGA.
Pupils learn under a tree due to absence of classrooms.

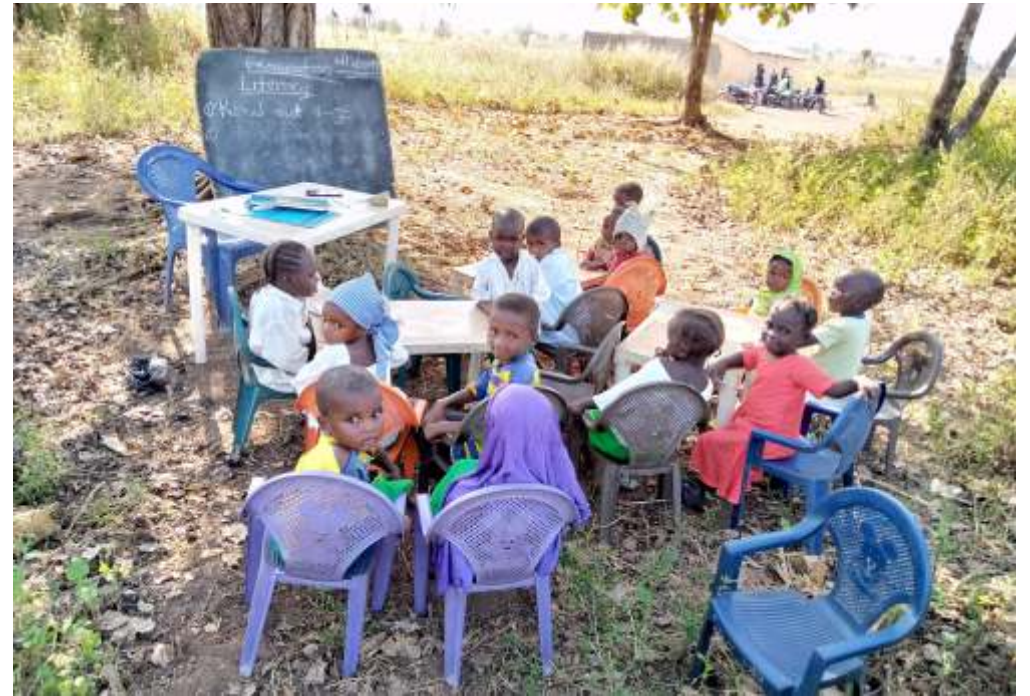
UBE Primary School, Mohanga, Fadan Karshi,
Sanga LGA. Pupils learn under a tree.

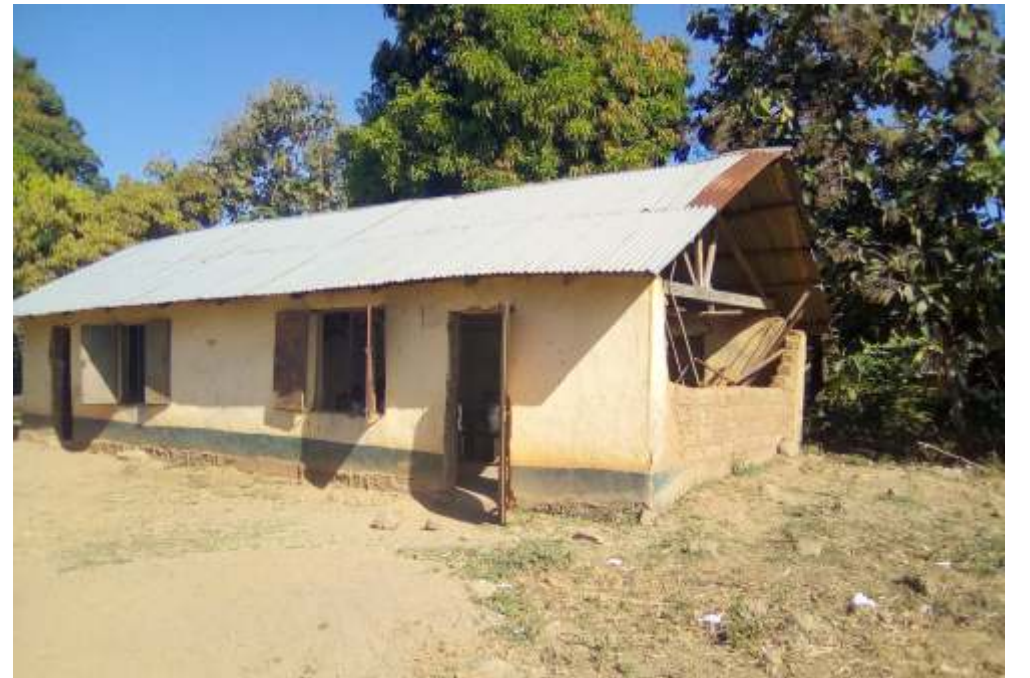
LGEA Primary School, Unguwan Gajere, Sanga LGA.
The wall of the classroom has fallen.

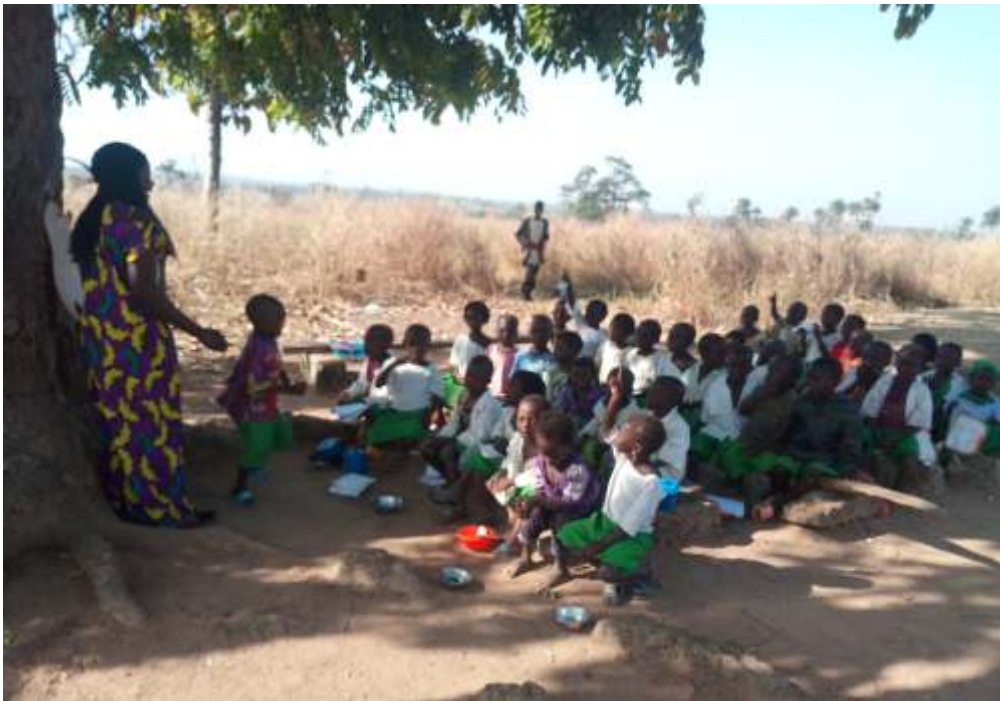
LGEA Primary School, Ningon, Sanga LGA.
Pupils learn under a tree.

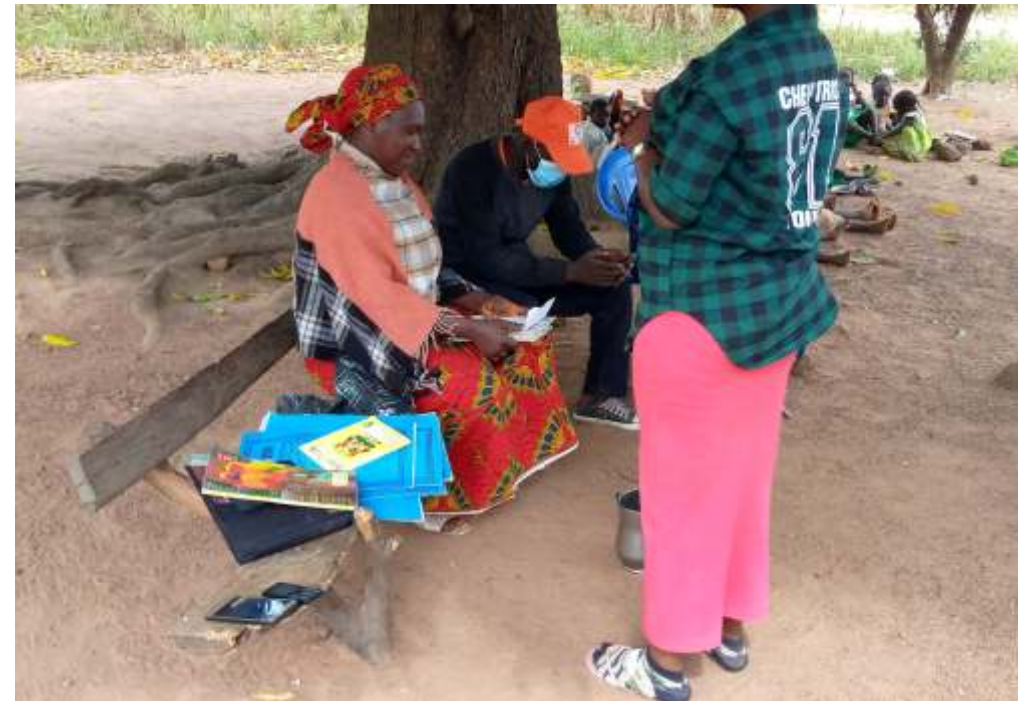
UBE Primary School, Ankirin, Sanga LGA.
This is the Head Master's office under a tree.

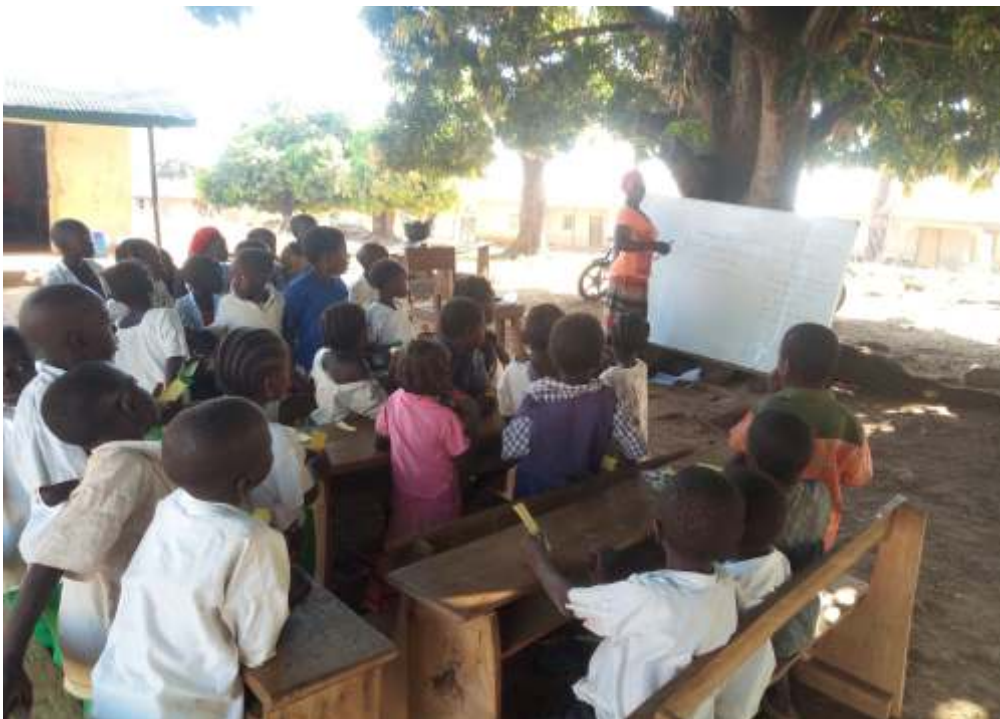
LGEA Primary School, Nandu B, Sanga LGA.
Pupils learning under a tree.

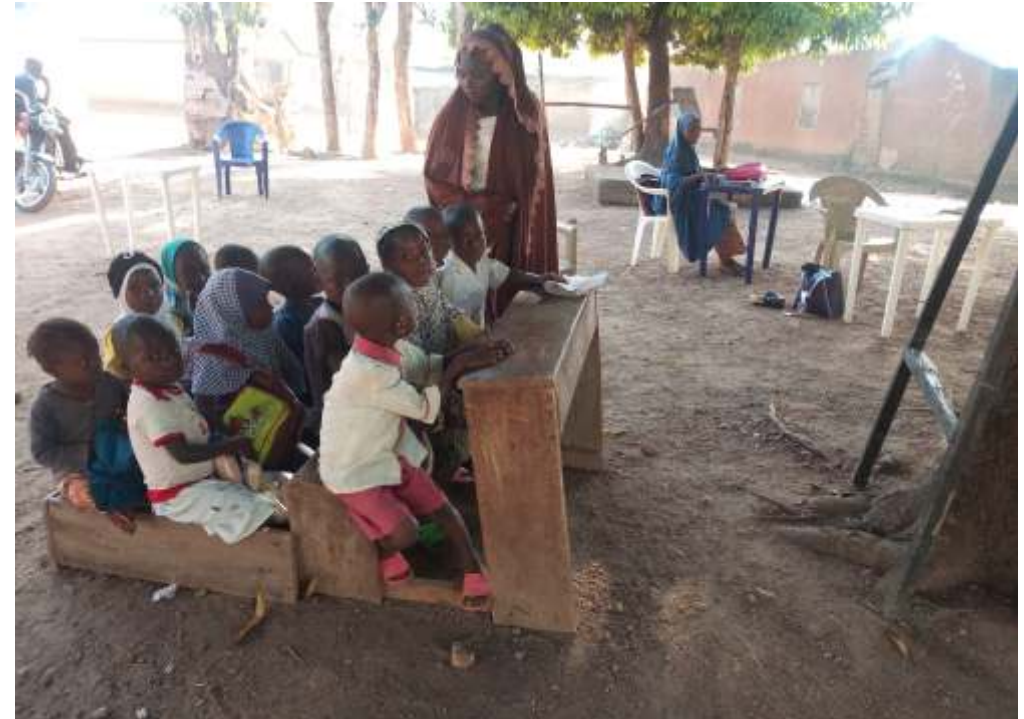
Integrated Quaranic Primary School, Gwantu, Sanga LGA.
Pupils learn under a tree.

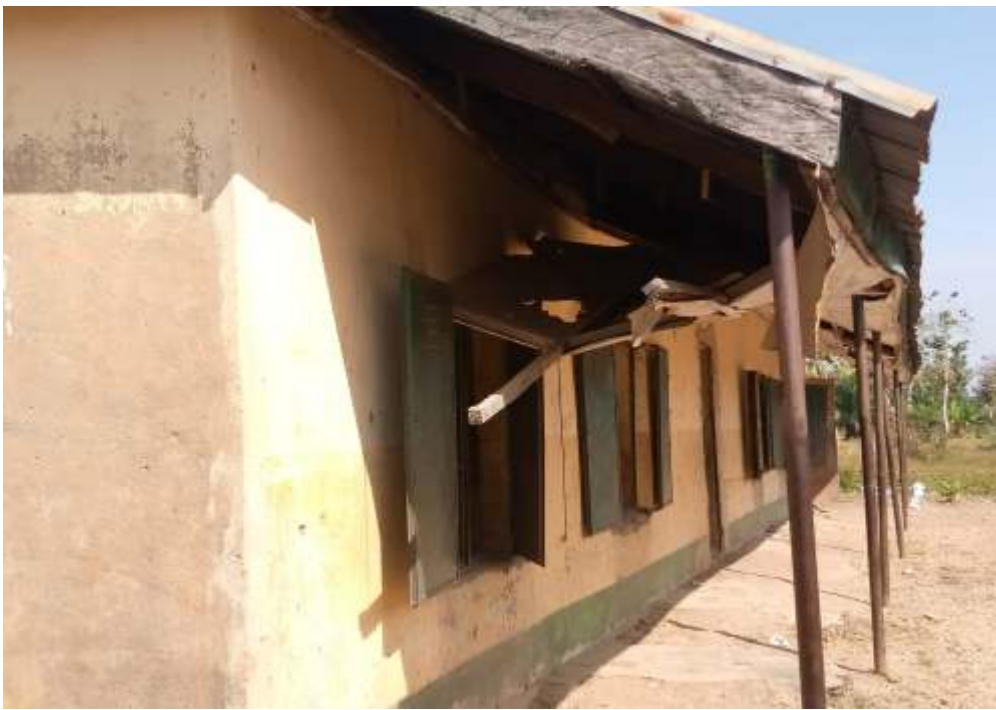
LGEA Primary School, Tsauni Kulere, Sanga LGA.
The ceiling of the classroom is crumbling.

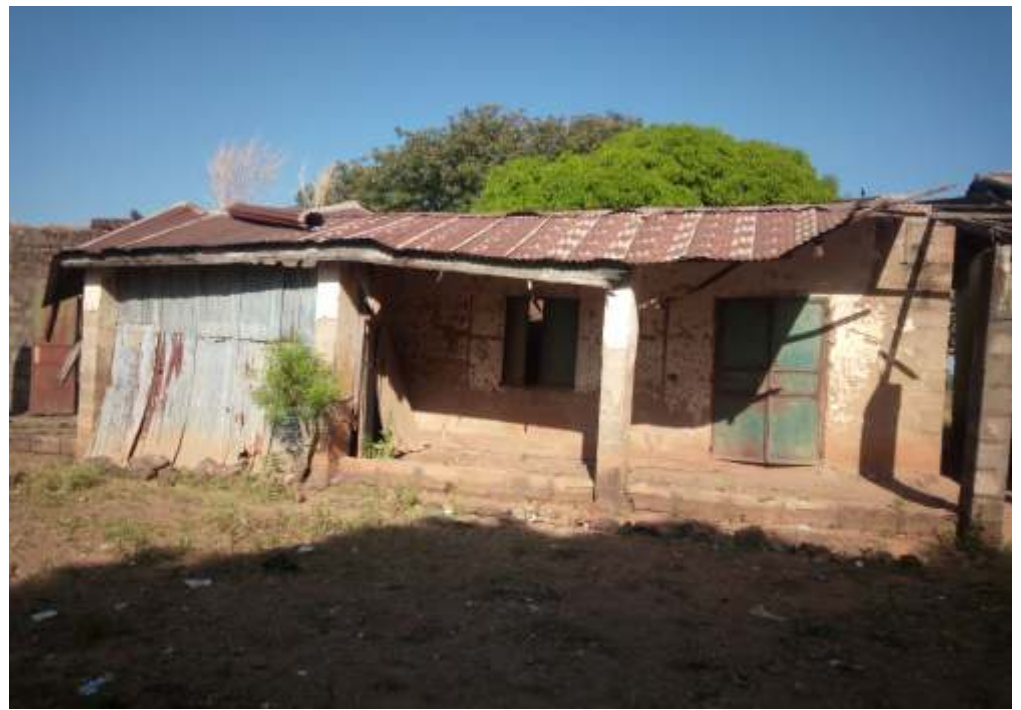
LGEA Primary School, Nandu B, Sanga LGA.
A dilapidated block of classrooms.

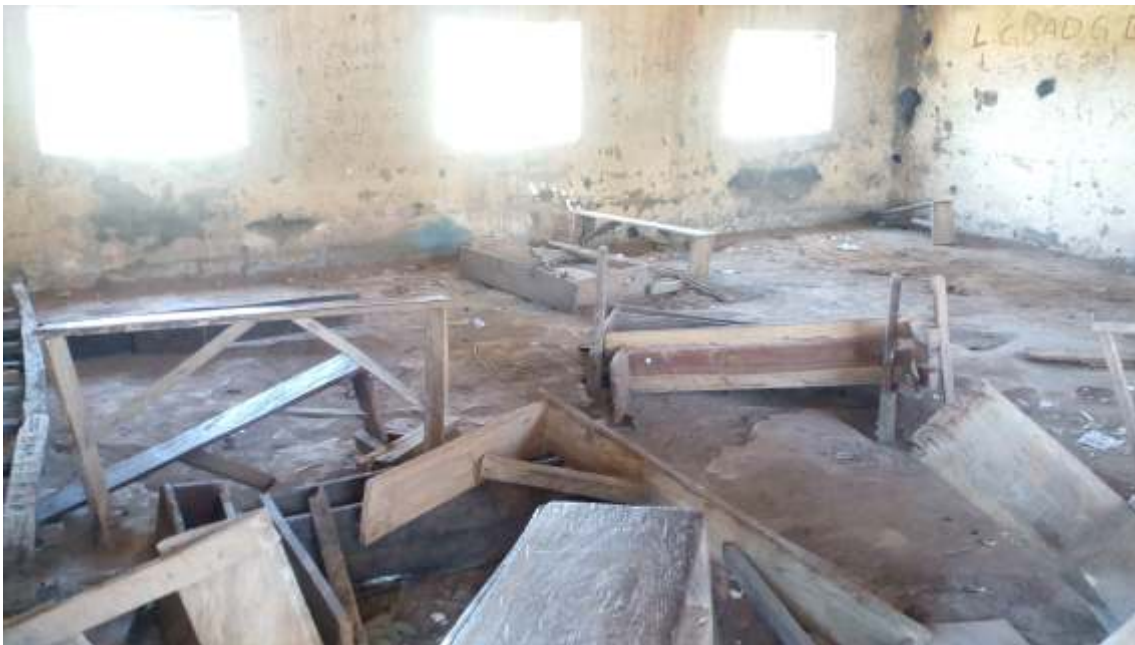
Government Secondary School, Gbonkpok, Arak, Sanga LGA.
Dilapidated and abandoned reading furniture.

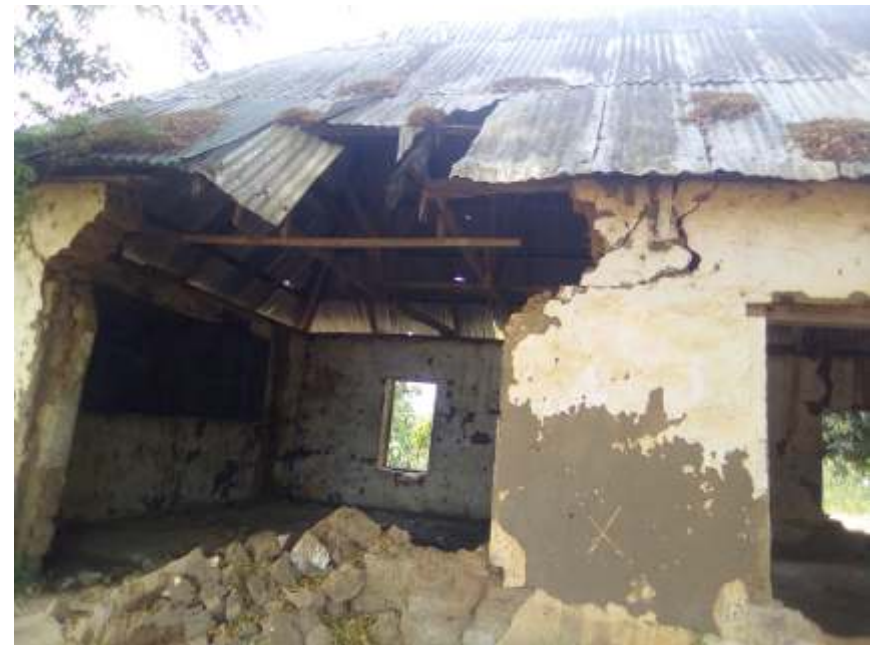
Government Junior Secondary School, Randa, Sanga LGA.
Dilapidated and abandoned block of classrooms

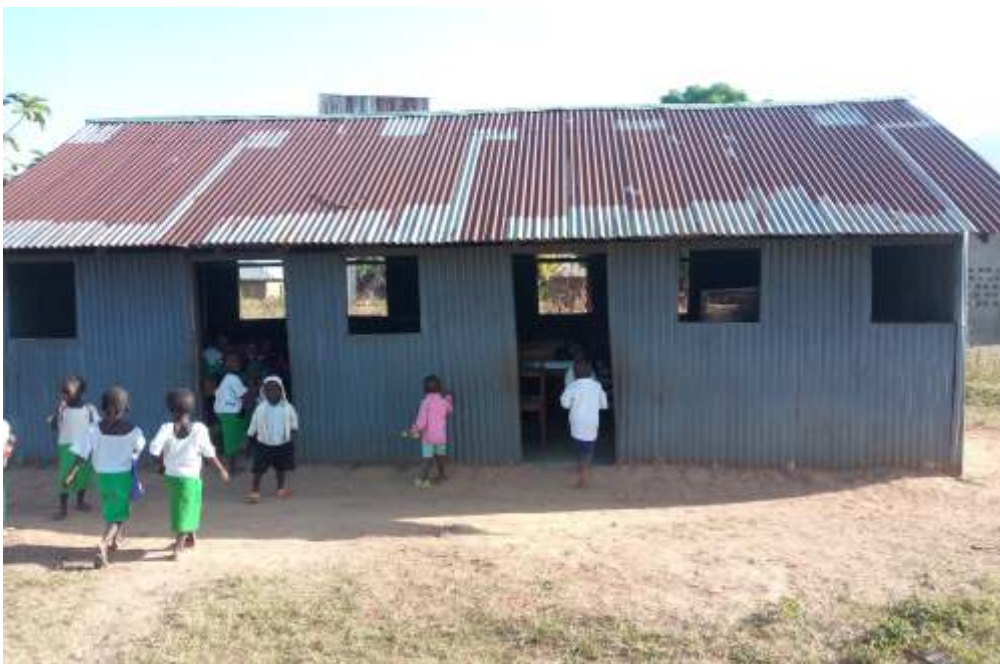
LGEA Primary School, Nandu B, Sanga LGA.
Classroom made from roofing zinc.
Not conducive for learning.

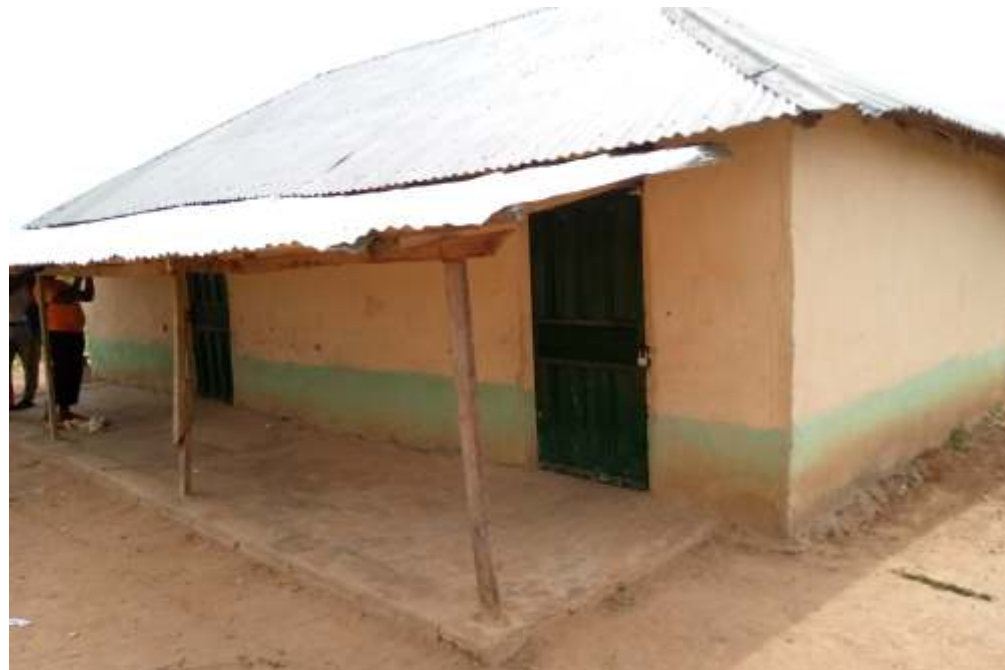
UBE Primary School, Anguwan Magaji, Sanga LGA.
This is the only structure in the school. Other pupils
learn under the tree.

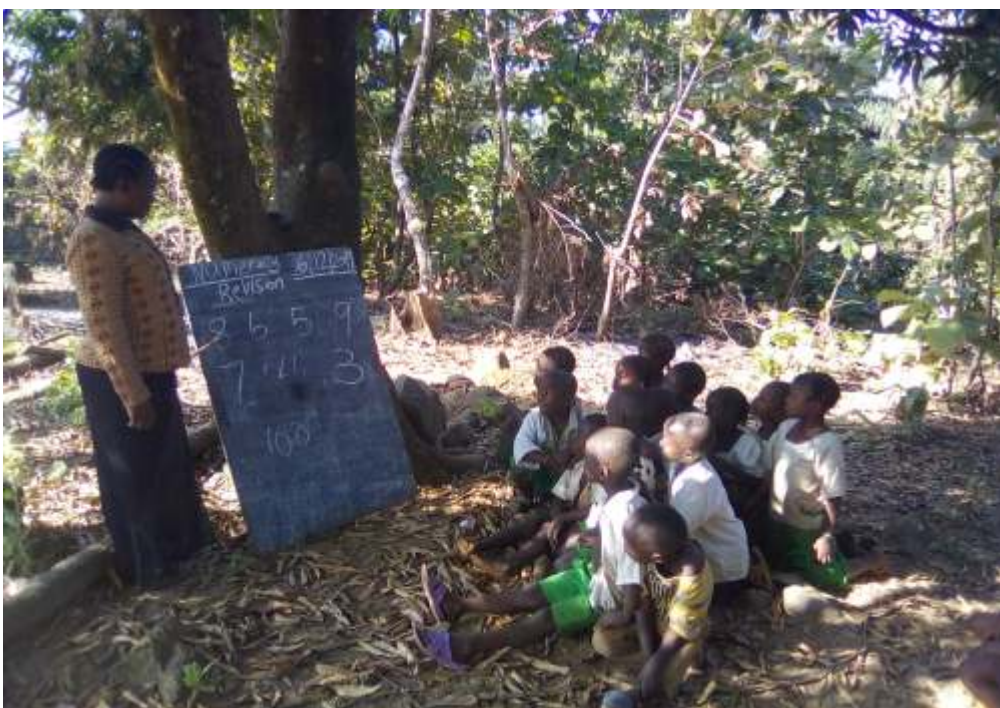
LGEA Primary School, Unguwan Gajere, Sanga LGA.
Pupils learn under a tree.

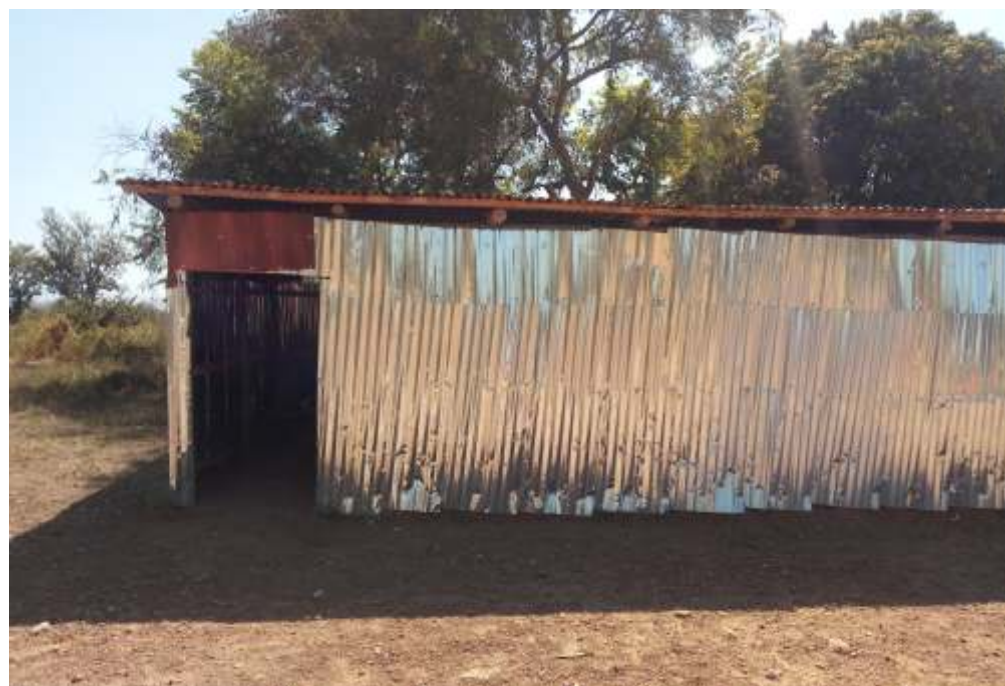
LGEA Primary School, Kobin, Sanga LGA.
Classroom built with roofing zinc sheet.
Not conducive for learning

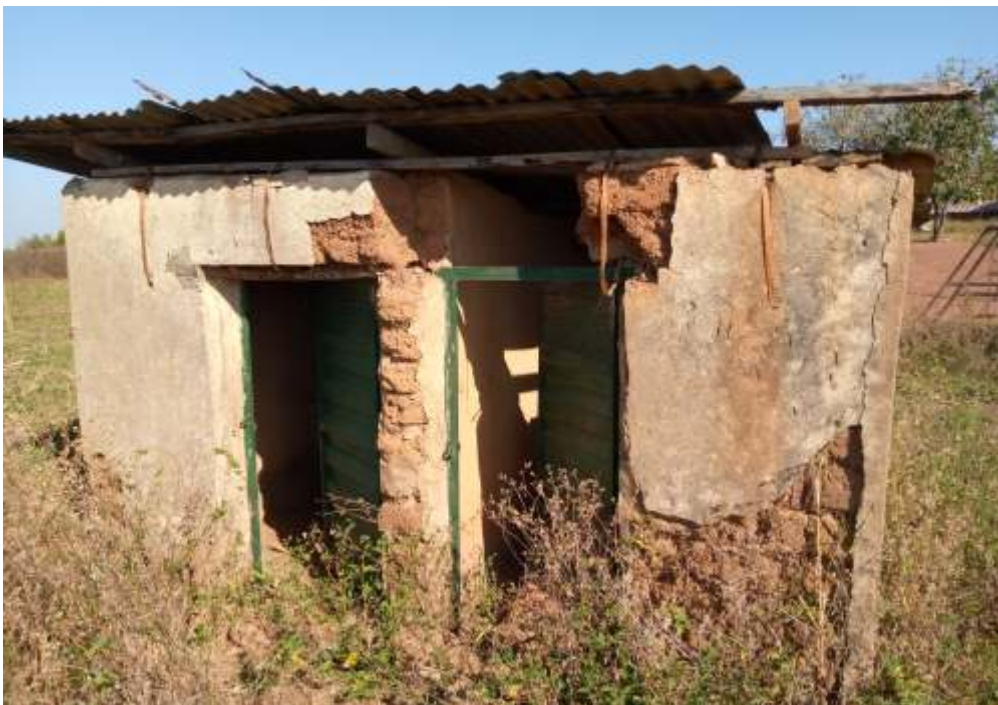
UBE Primary School, Mohanga, Fadan Karshi, Sanga LGA. The only toilet in the school. It is abandoned. Pupils resort to open defecation.

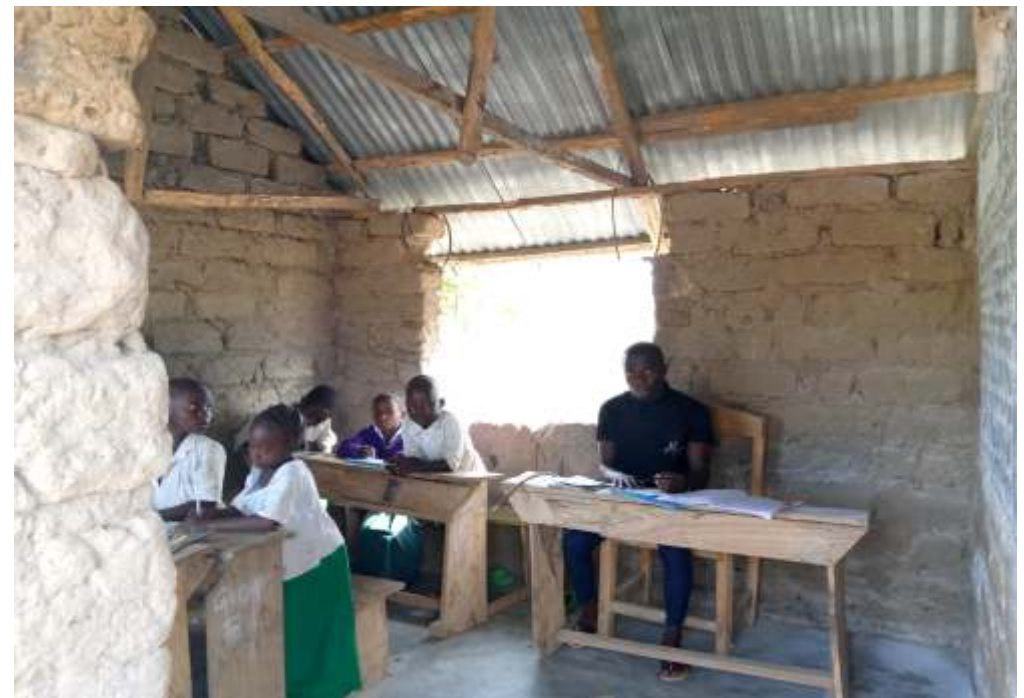
UBE Primary School, Unguwar Bera, Sanga LGA. A classroom without windows or doors.

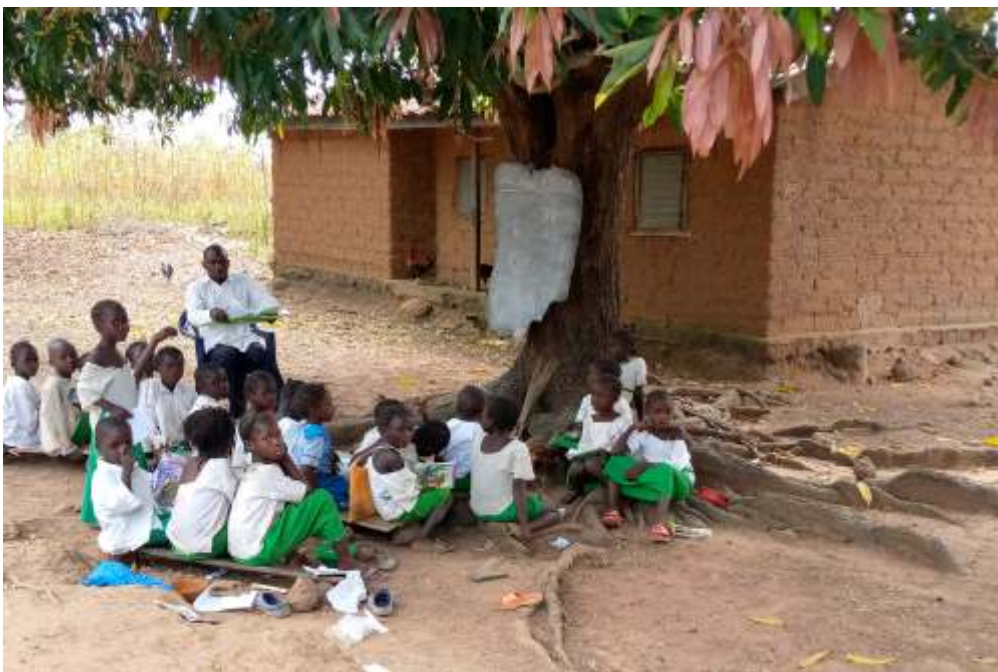
UBE Primary School, Ankirin, Sanga LGA. Pupils learn under a tree.

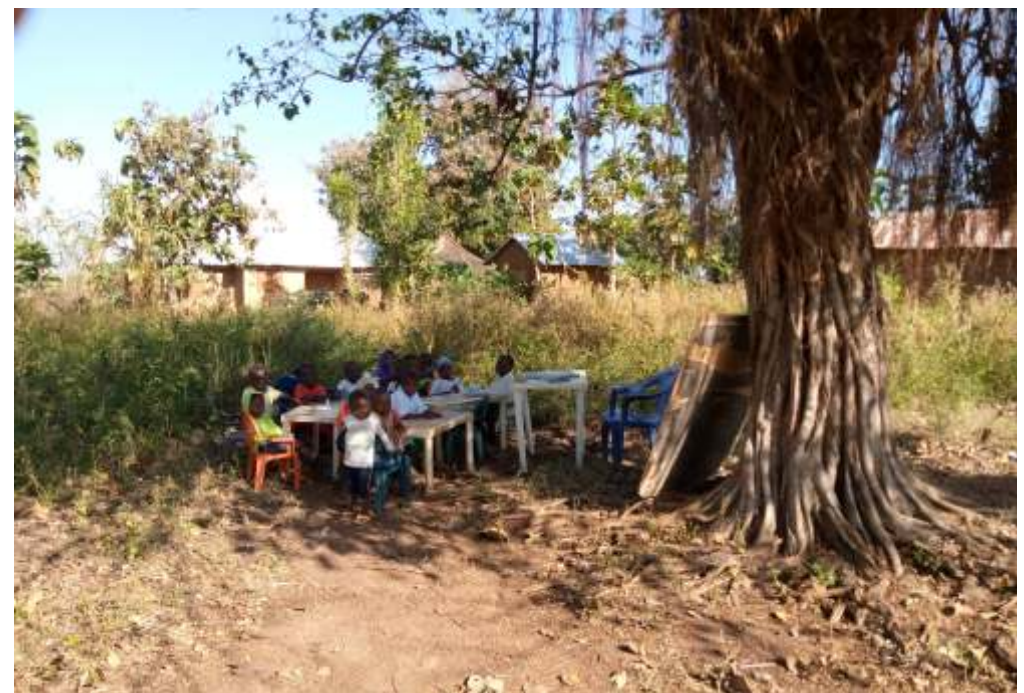
UBE Primary school, Mohanga, Fadan Karshi, Sanga LGA. Pupils learn under a tree.
