*A Pictorial Essay Of The Poor Learning Environment In Selected Schools In
Ikara And Sanga Local Government Areas Of Kaduna State*

Produced by
Community Life Project (CLP) - Reclaim Nigeria

COMMUNITY LIFE PROJECT (CLP)
SEPTEMBER 07, 2020

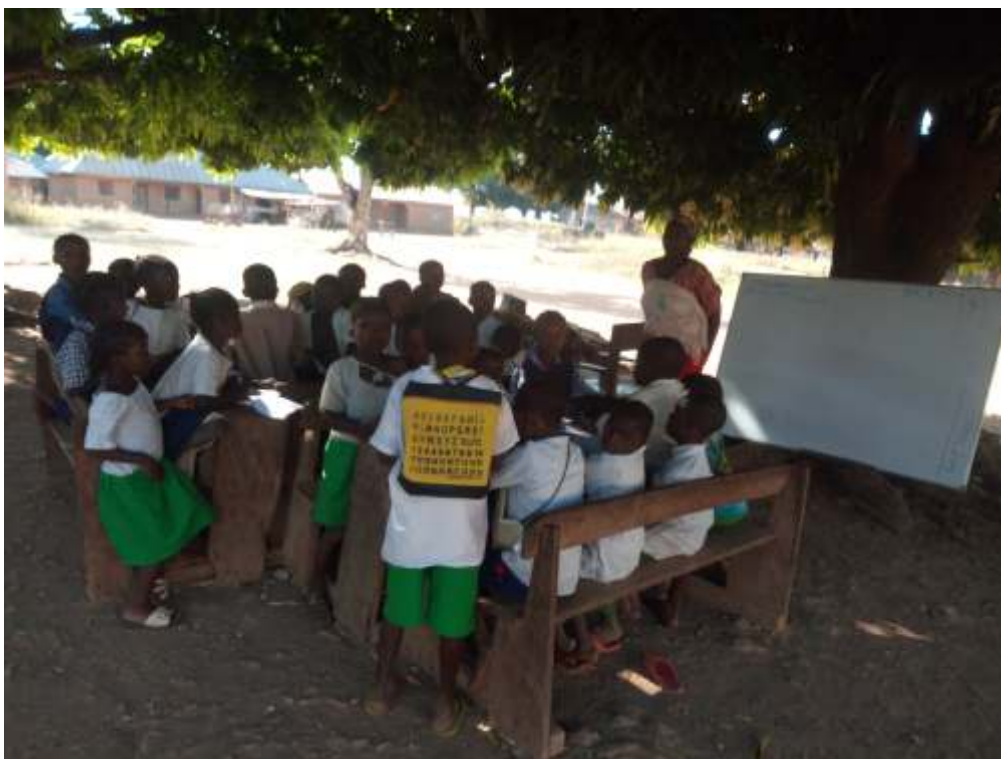
LGEA Primary School, Nandu B, Sanga LGA. Pupils learning under the tree.

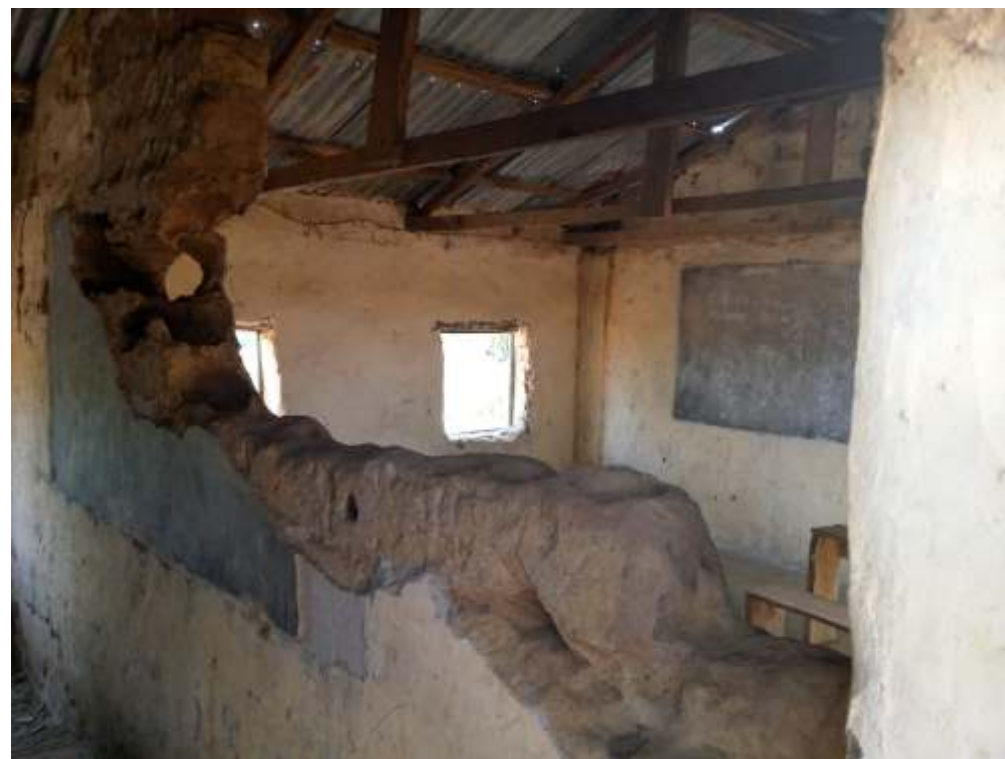
LGEA Primary School, Unguwan Makama, Sanga LGA. A dilapidated classroom.

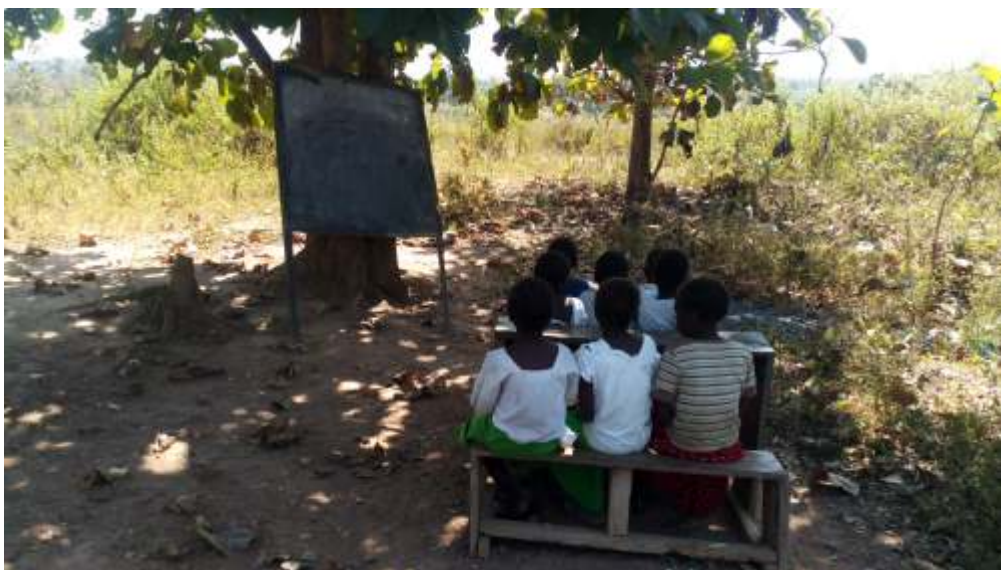
UBE Primary School, Unguwan Galadima, Sanga LGA. Pupils learn under a tree.

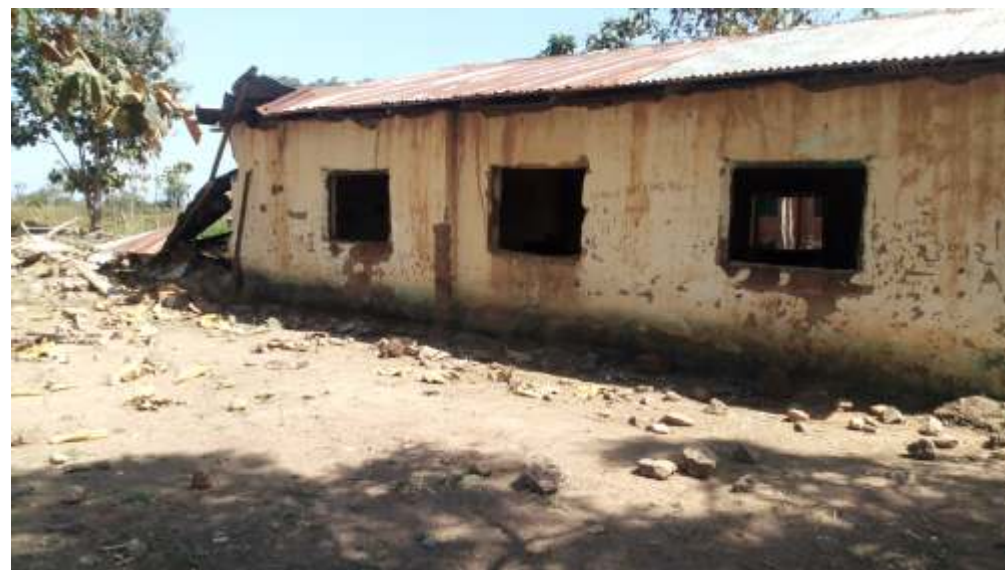
Government Secondary School, Gbonkpok, Arak, Sanga LGA. A dilapidated block of classrooms with broken windows and falling wall.

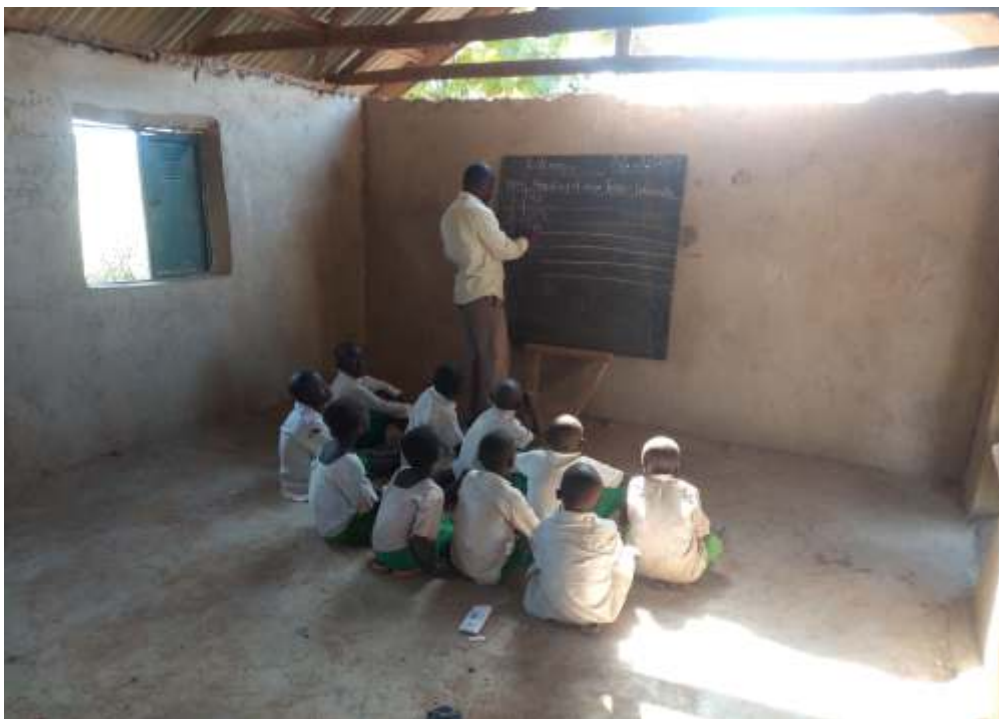
UBE Primary school, Gajere, Sanga LGA.
Pupils sit on the floor to learn due to non-availability of tables and chairs.

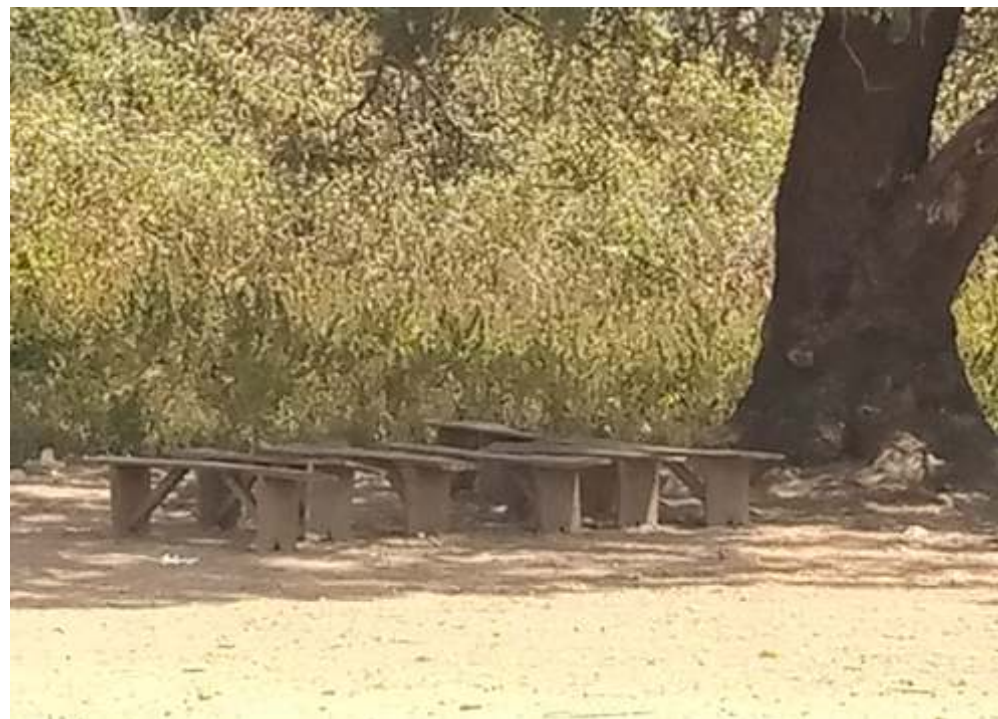
LGEA Primary School, Unguwar Jirgi, Sanga LGA.
Classroom under a tree.

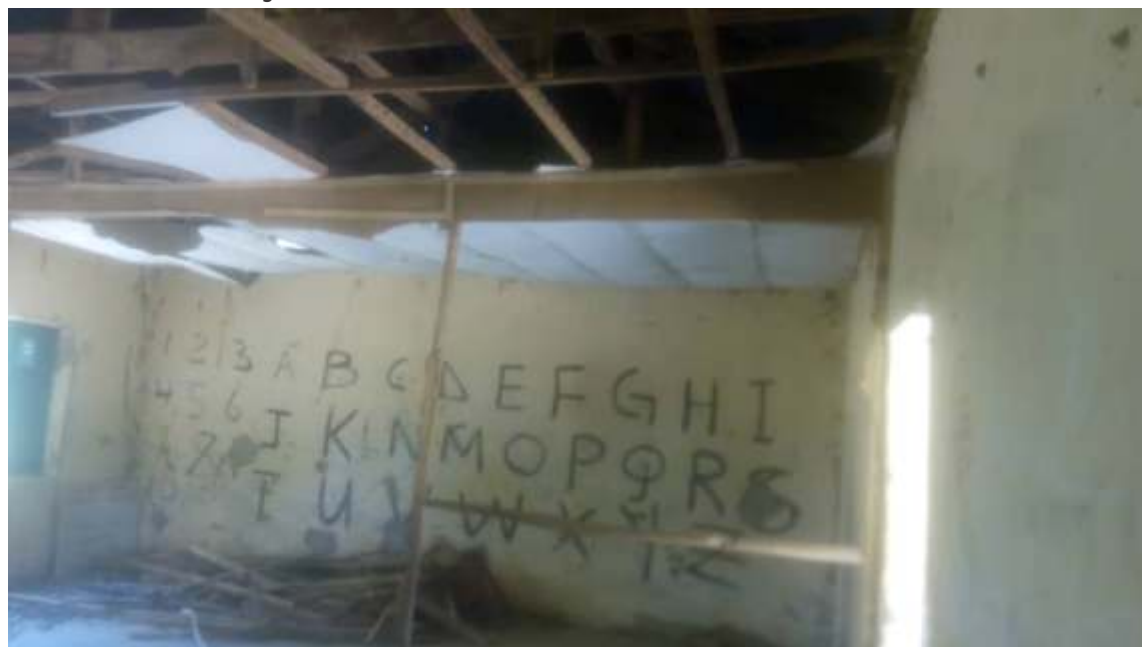
LGEA Primary School, Anguwar Ibrahim, Sanga LGA.
Classroom with the ceiling and roof crumbling

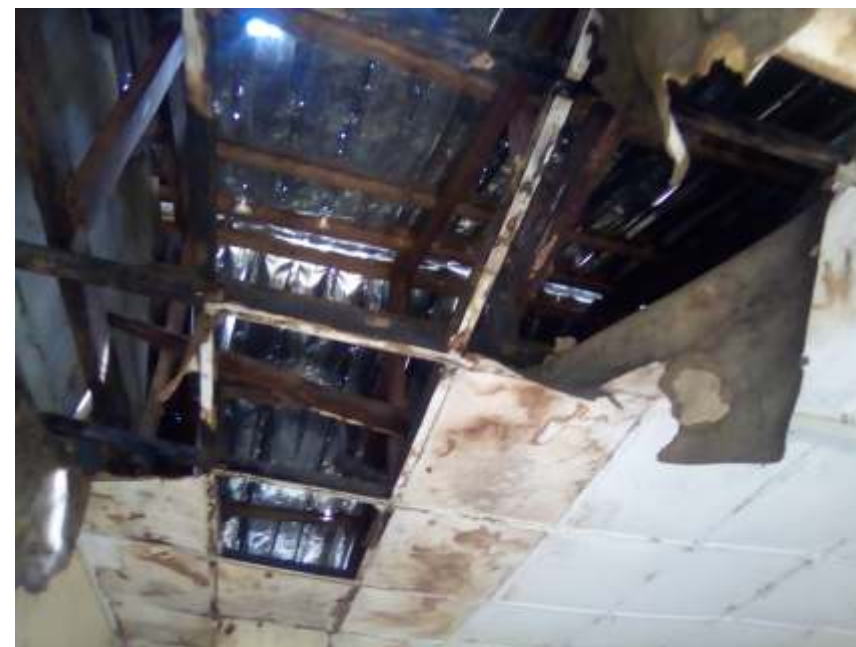
Government Junior Secondary School, Randa, Sanga LGA. Classroom with broken ceiling.

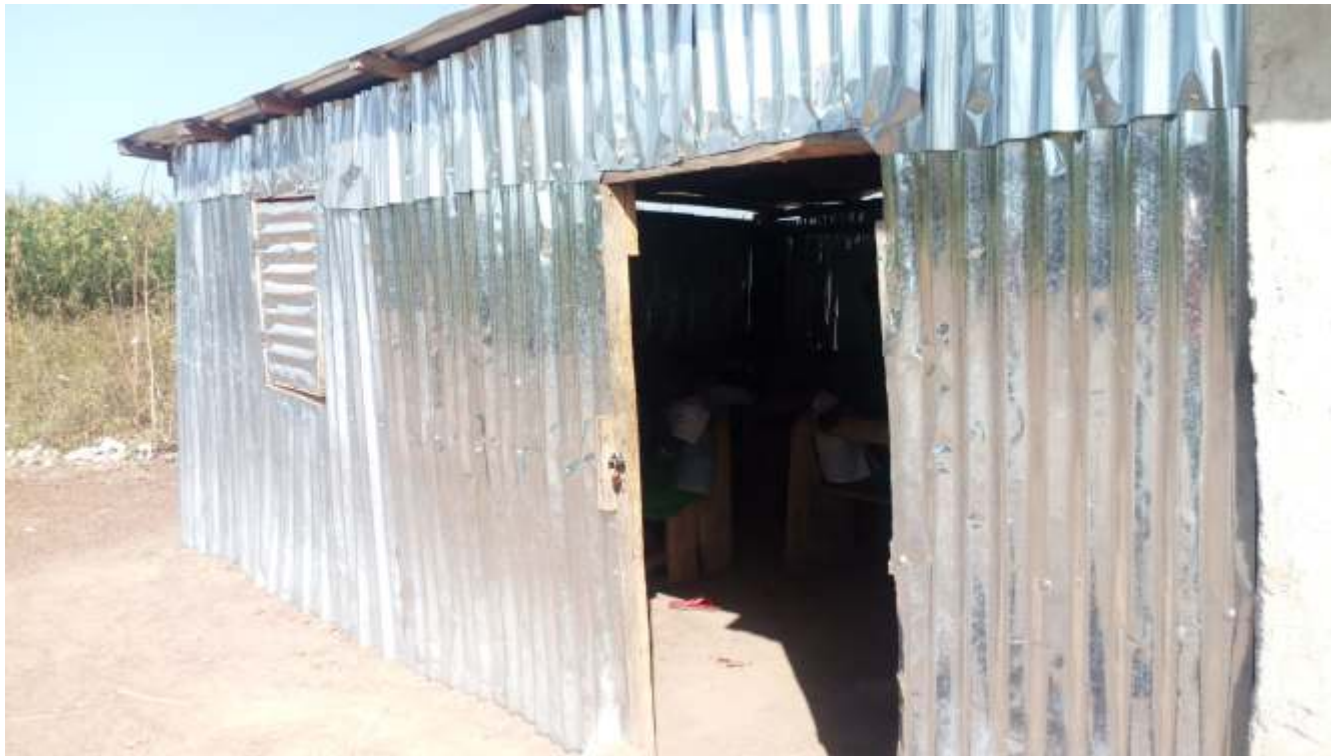
Nomadic Primary School,
Unguwar Ganye, Sanga LGA.
Classroom built with roofing
zinc sheet. Not conducive for
learning

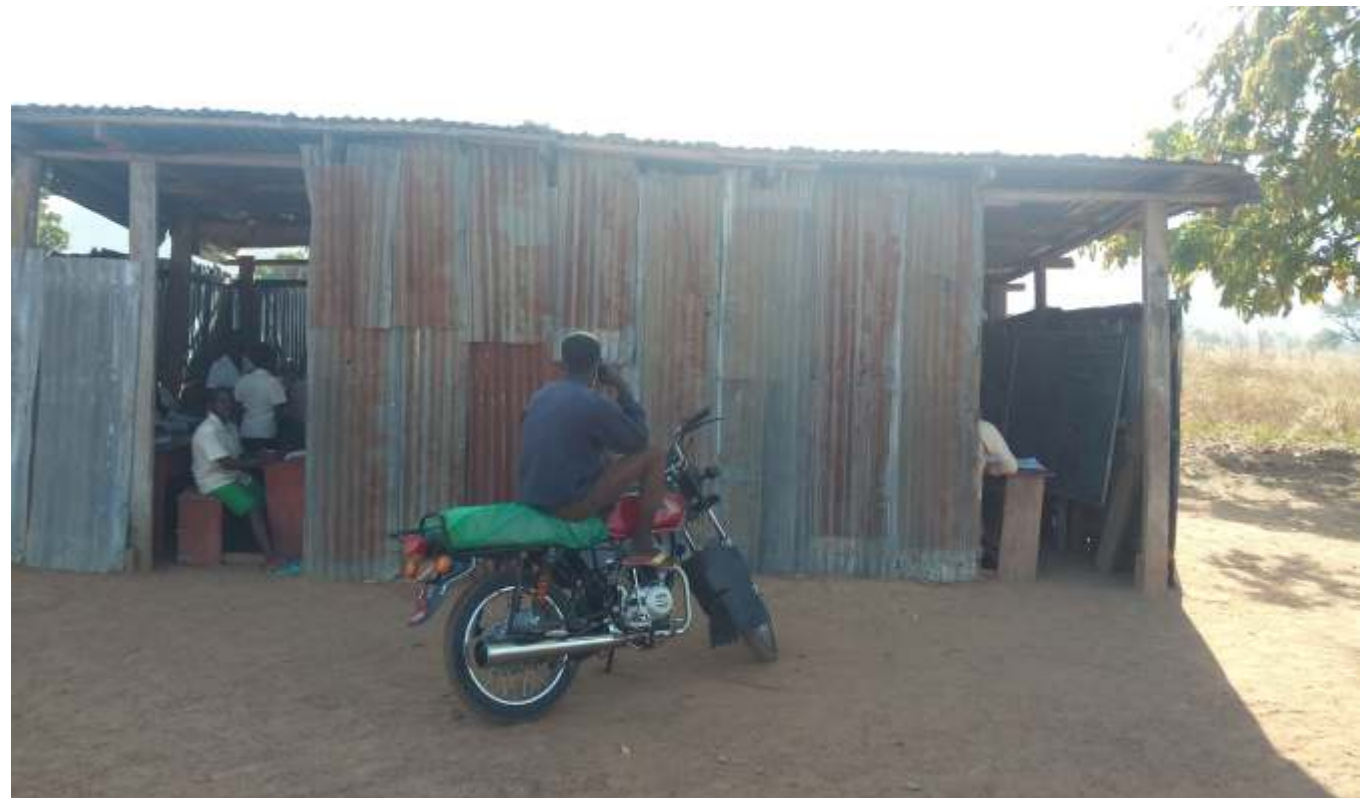
LGEA Primary School,
Ningon, Sanga LGA.
A classroom made of
roofing zinc

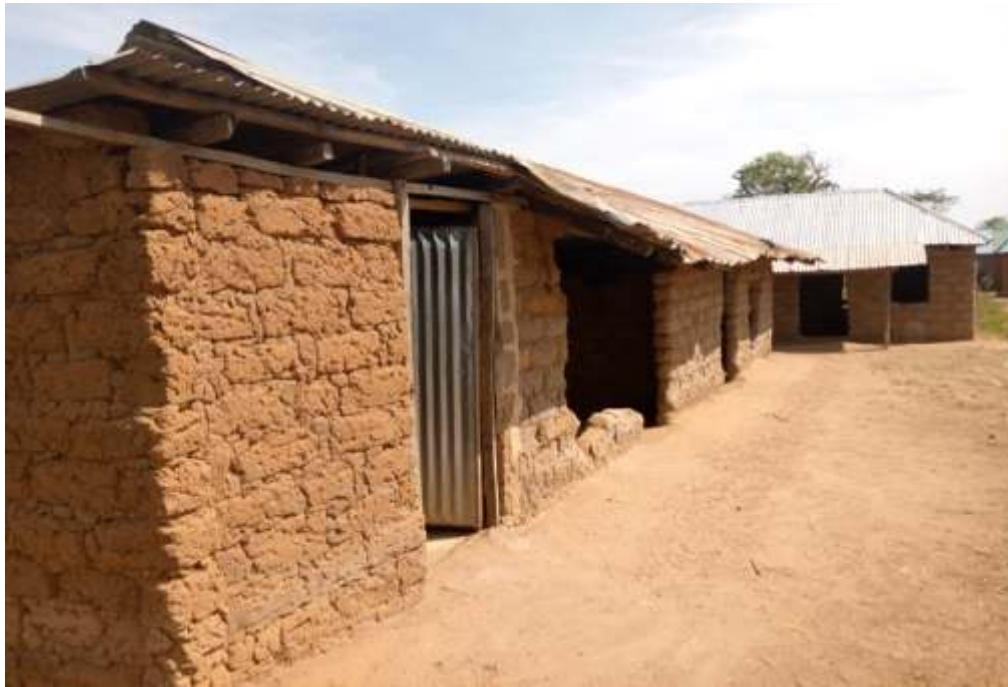
UBE Primary School, Akwa.
Block of classrooms.

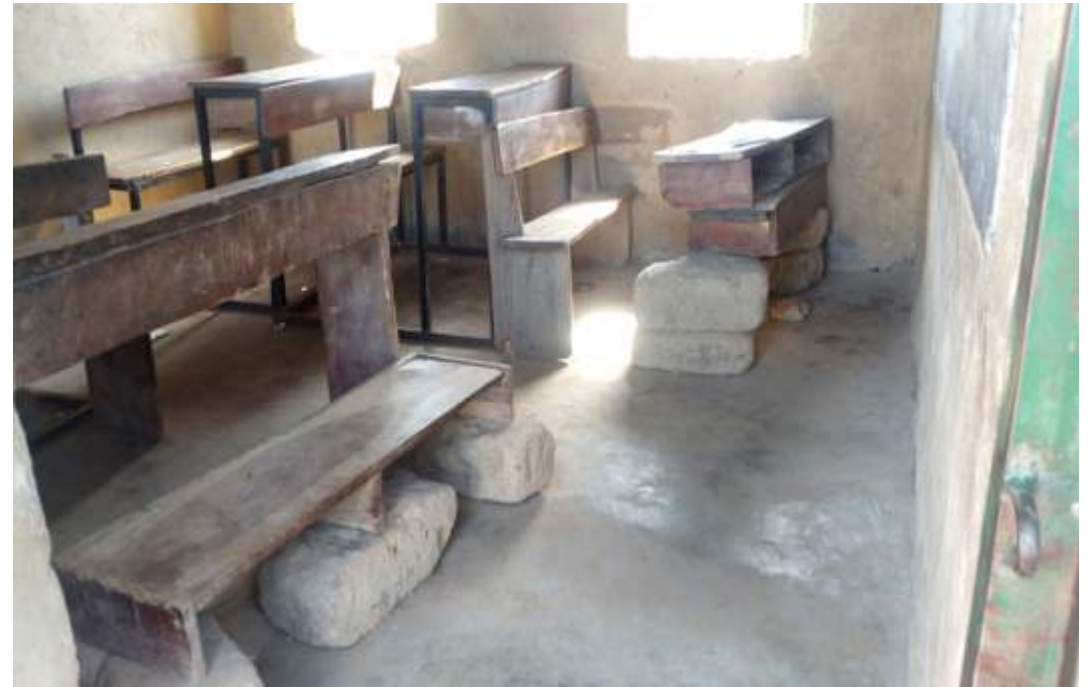
UBE Primary School, Akwa.
Classroom setting with makeshift seats for pupils.

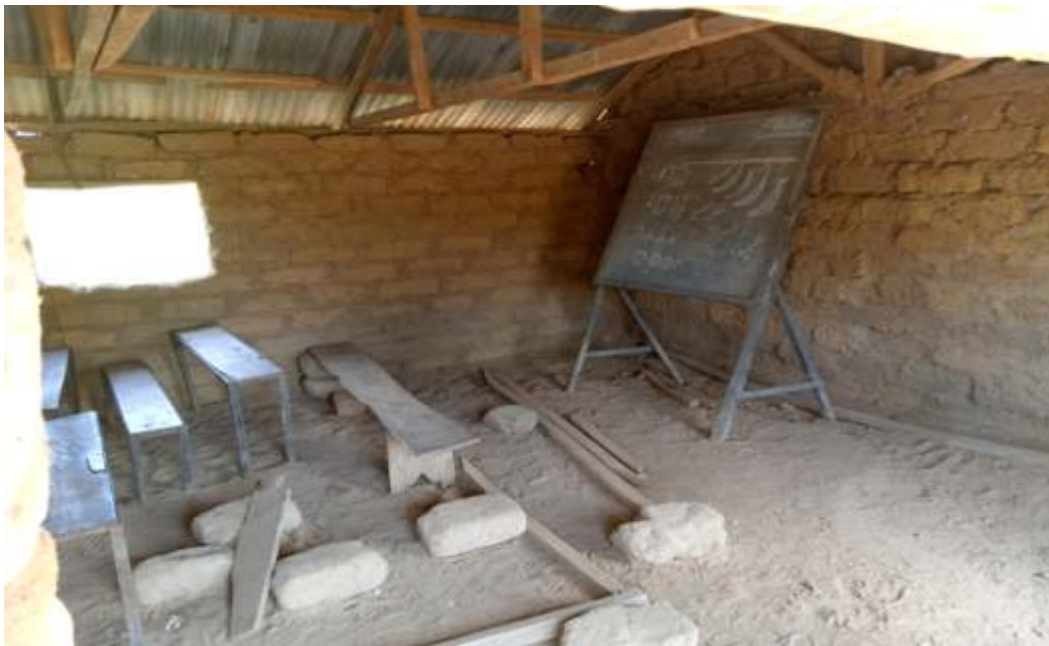
UBE Primary School Unguwar Doka.
Classroom with makeshift seats for pupils.

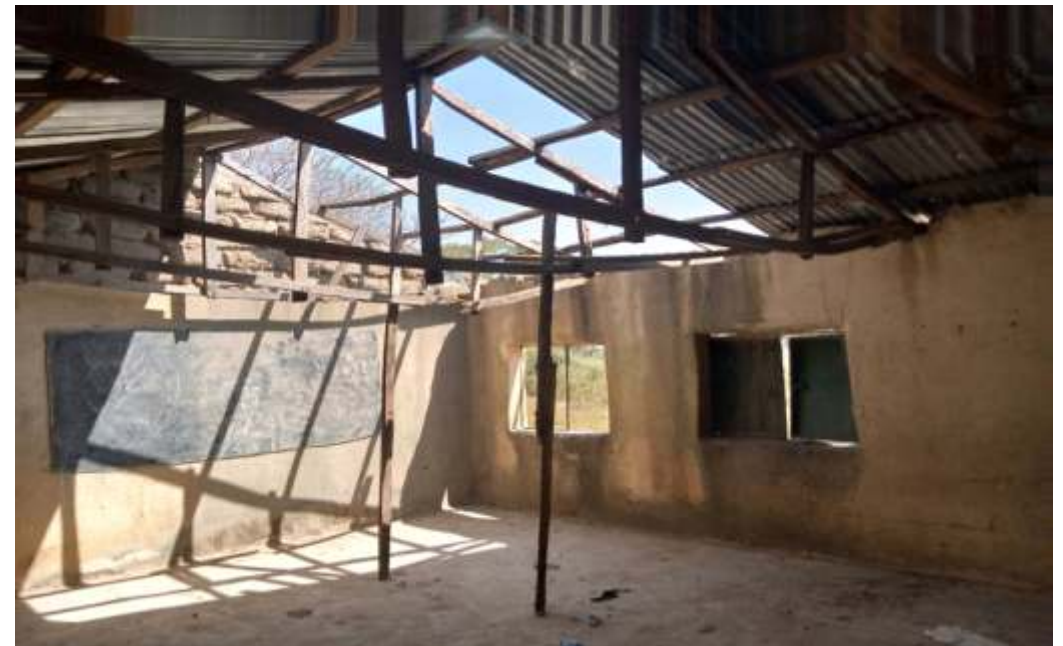
UBE Primary School, Wasa North.
Classroom with roof blown off.

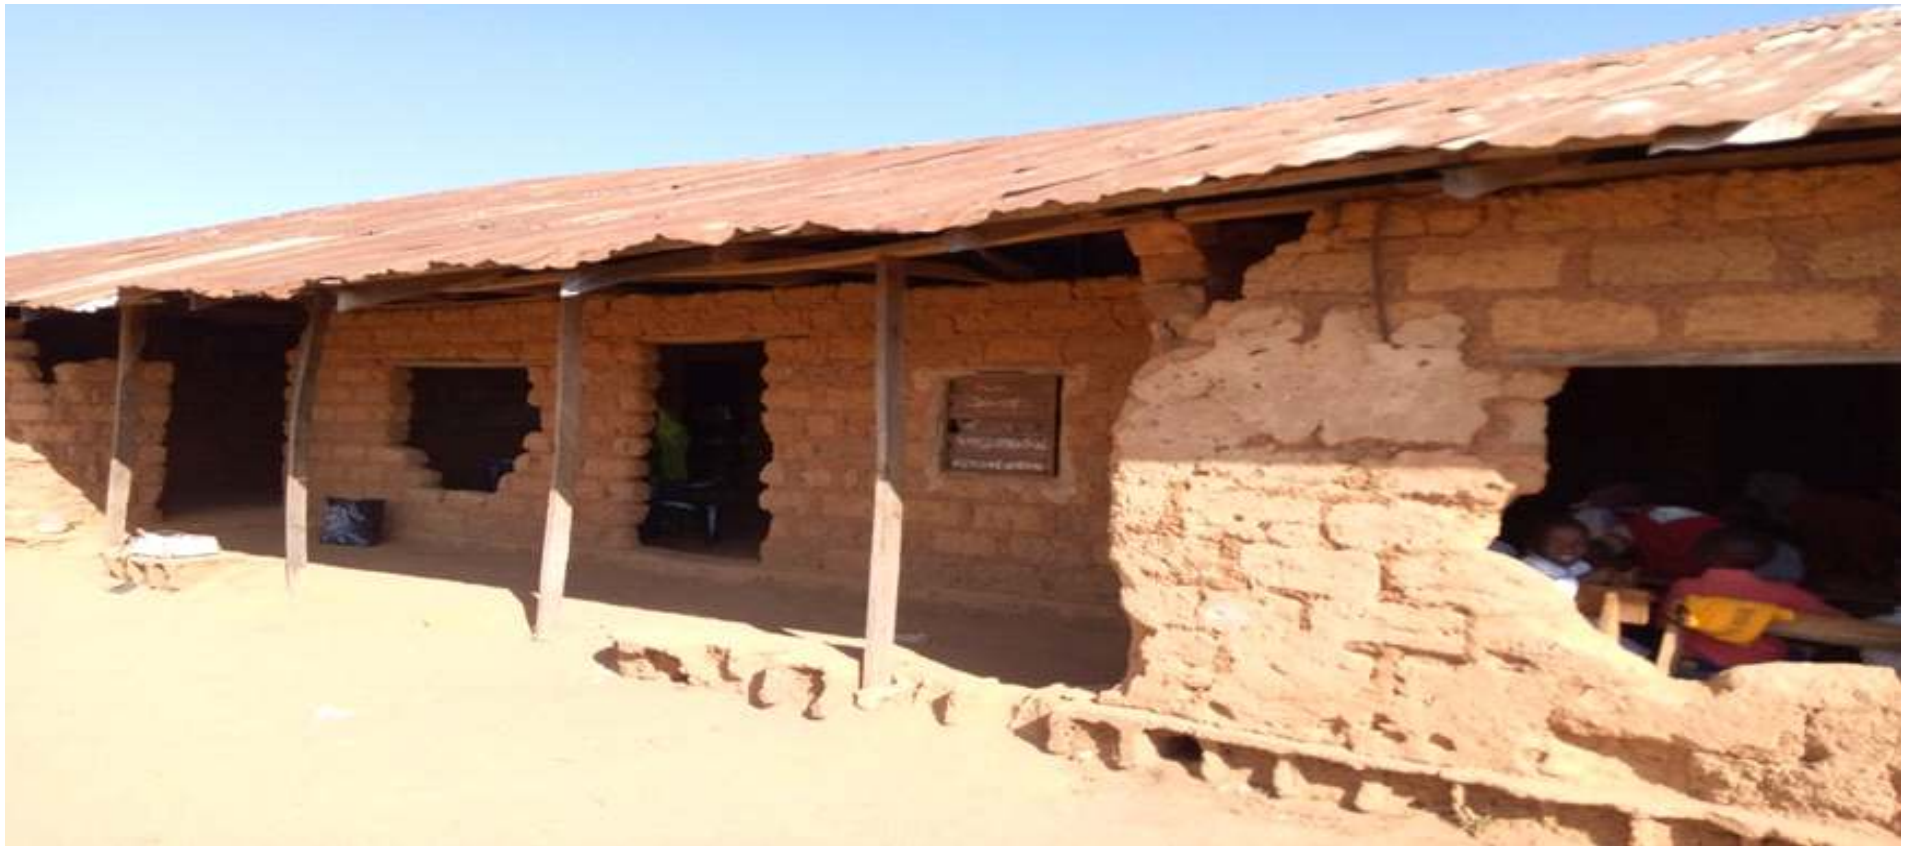
UBE Primary School, Kyamiyah Fadan Karshi. Dilapidated block of classrooms with pupils inside.

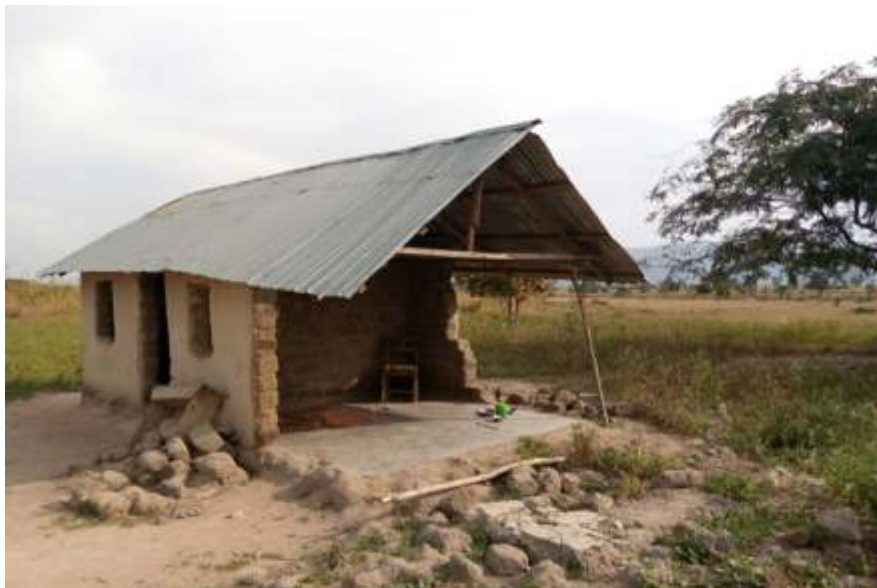
UBE Primary School Unguwar Bera. Dilapidated block of classrooms.

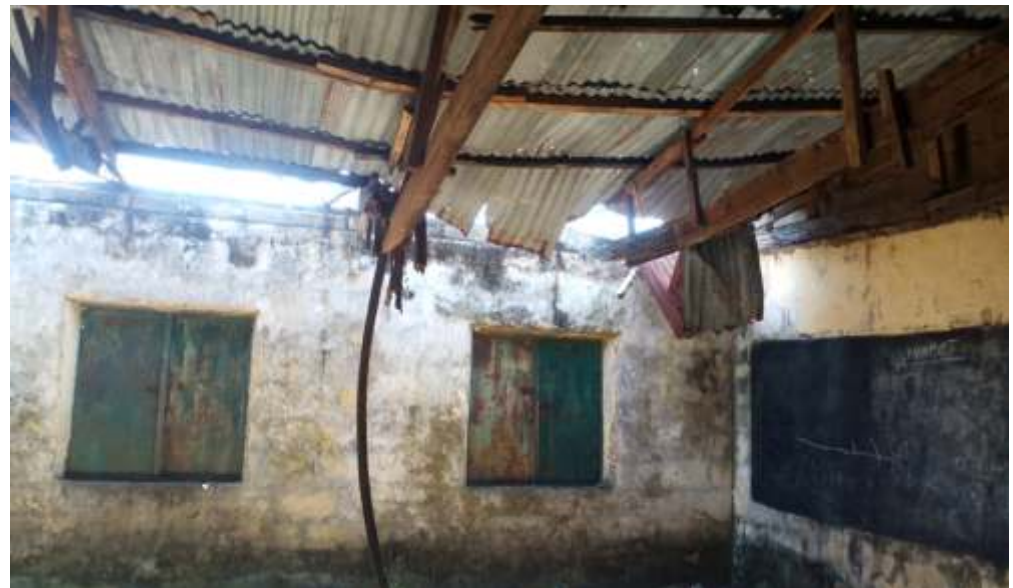
LGEA Primary School, Abari. Dilapidated classroom with falling roof.
